# **Integration Status**

# **UNIGE**

# AMS-02 Tracker - Plane 2

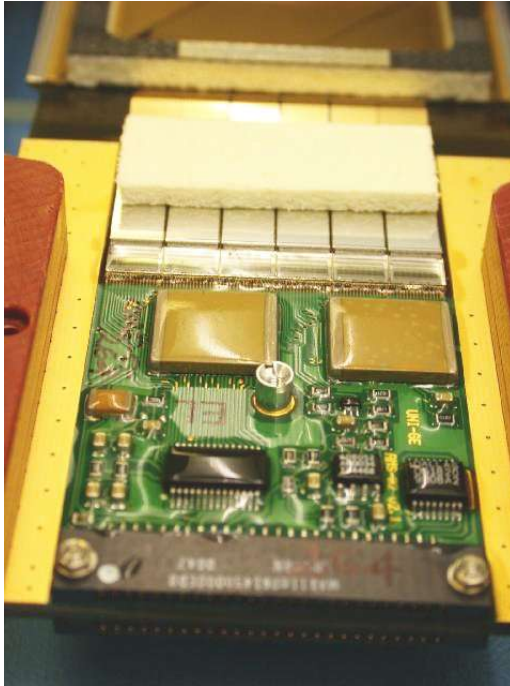
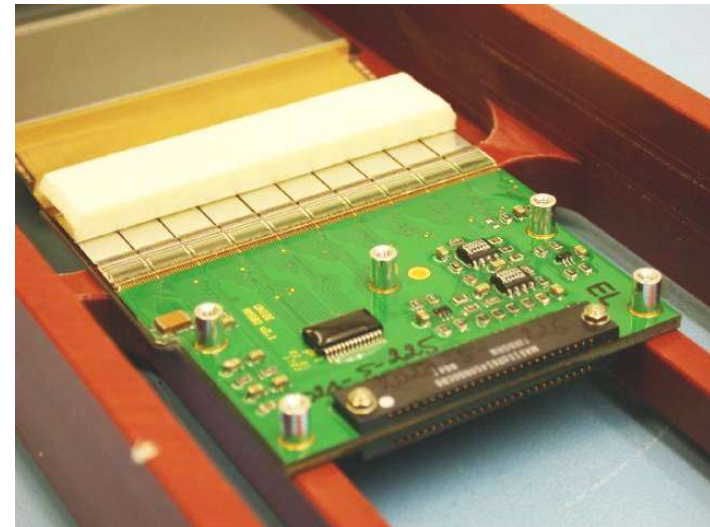
***Problem during L7 installation: S side airex unglued on L09AI091***

***Fixing: add redundant airex gluing points on both sides (S&K) for all ladders***

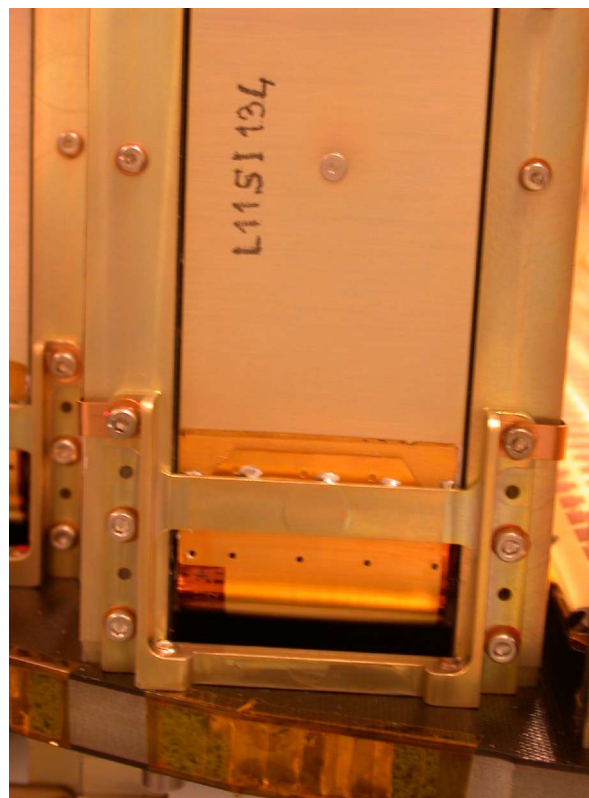
***tricky on K side: airex not visible!***

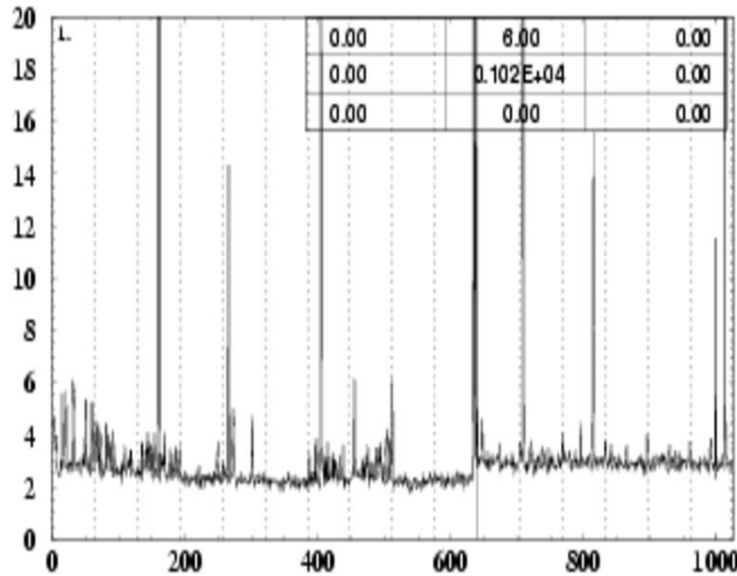
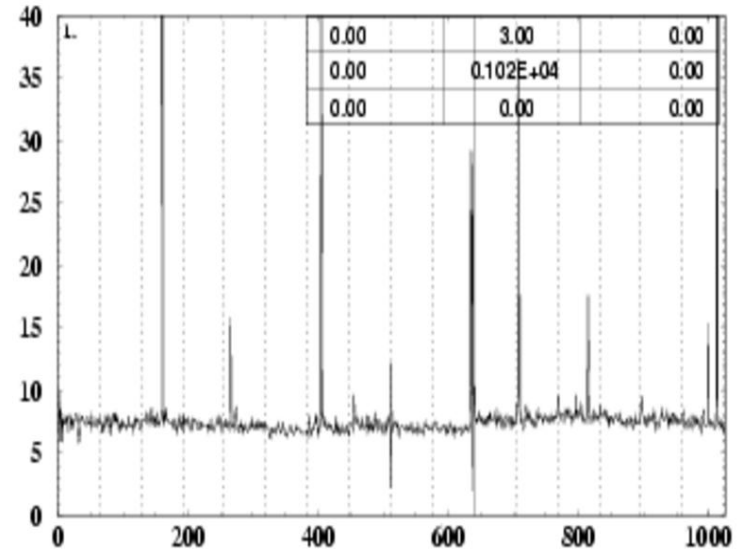
# Discovering hybrids capacitors damaged: an example L10A0151

**Guard-ring voltages: S-side= -2.0 V , K-side= +5.0V; Bias Voltage= 73 V**  
(standard values used when testing ladders)

**Similar behaviour on L10A0149, L11A0153, L14A0156 and L12AJ038**

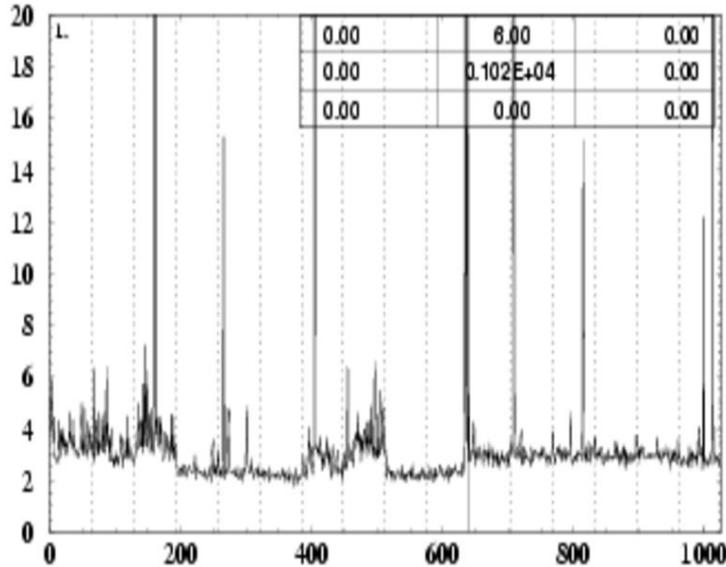
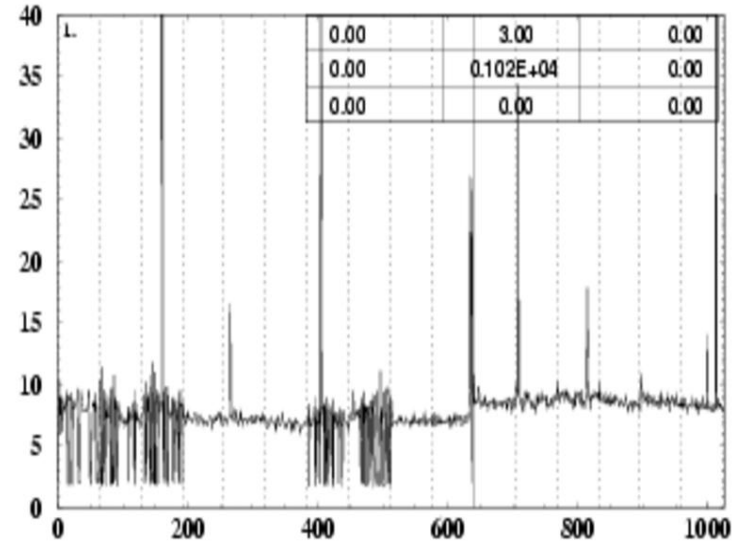
# *L10A0151 tested lowering S-side guard-ring voltage:*

*Guard-ring voltages: S-side= -5.3V , K-side= +5.0V; Bias Voltage= 70.1 V*

***Test shows clearly capacitors 1, 2, 3, 7 and 8 failure.***

***N.B. Testing afterwards with standard voltages values gives no low sraw channels.***

*Same test performed on L10A0149, L11A0153, L14A0156 and L12AJ038 has given same result.*

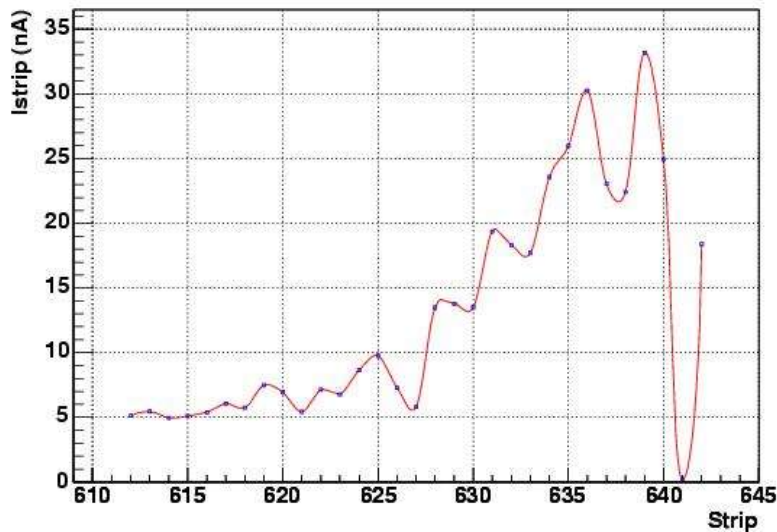
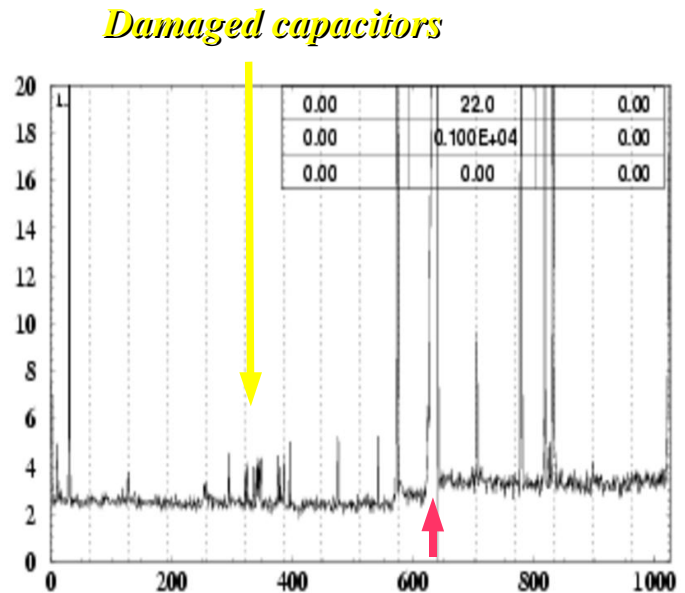
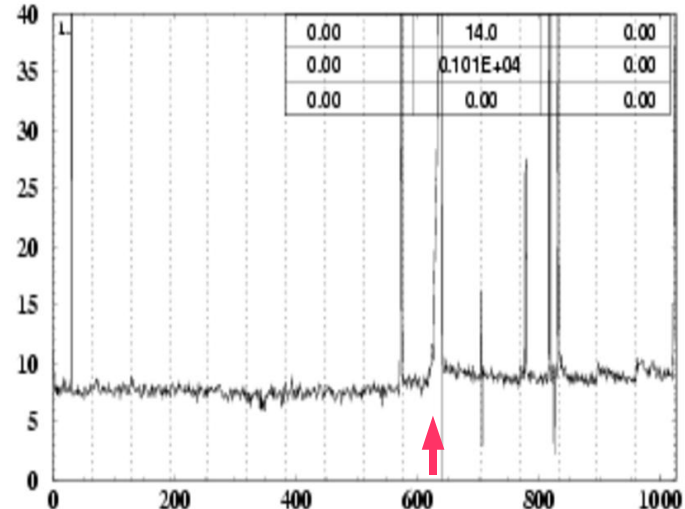
# L12AJ038: noisy peak on VA10

Measured current of silicon strips corresponding to noisy peak:

**Problem on chs ~615->640 originates from silicon.**

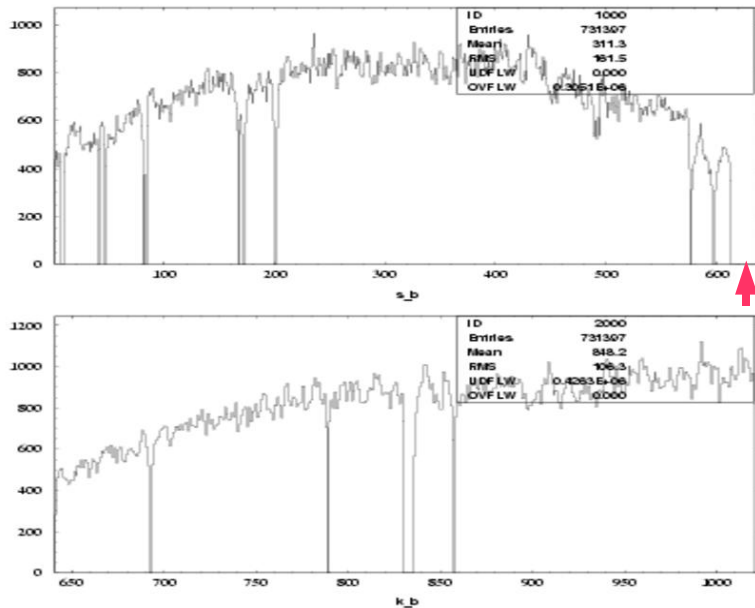
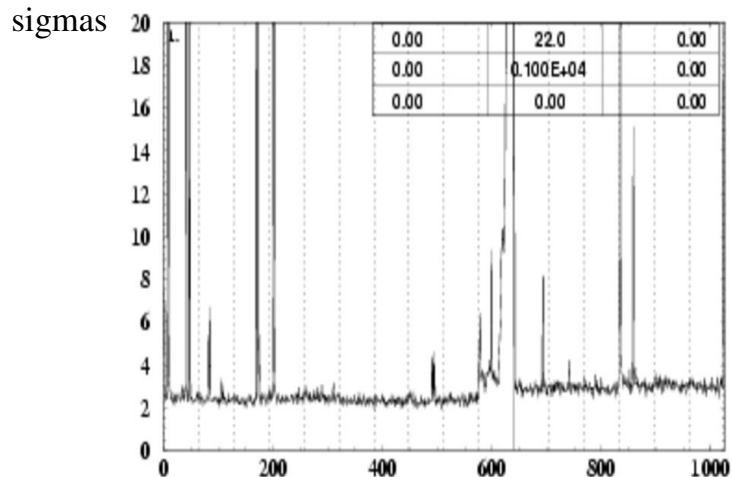
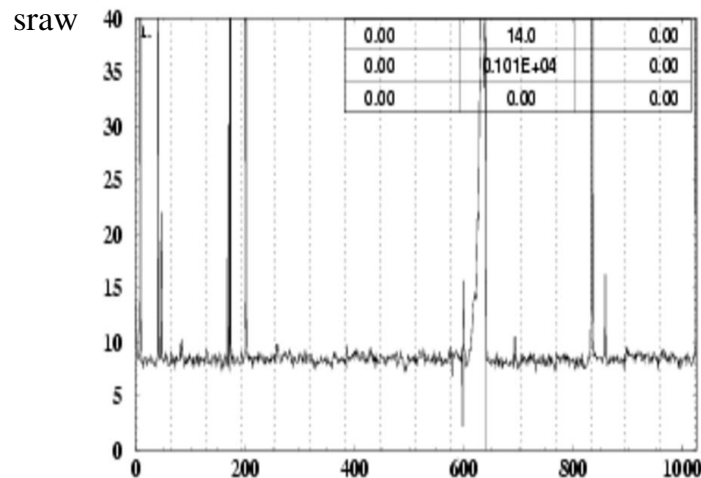
# L12AI067: noisy peak on VA10

*Same problem as L12AJ038,  
 "hole" on CHs 615->640:  
 keep as it is or reject?*

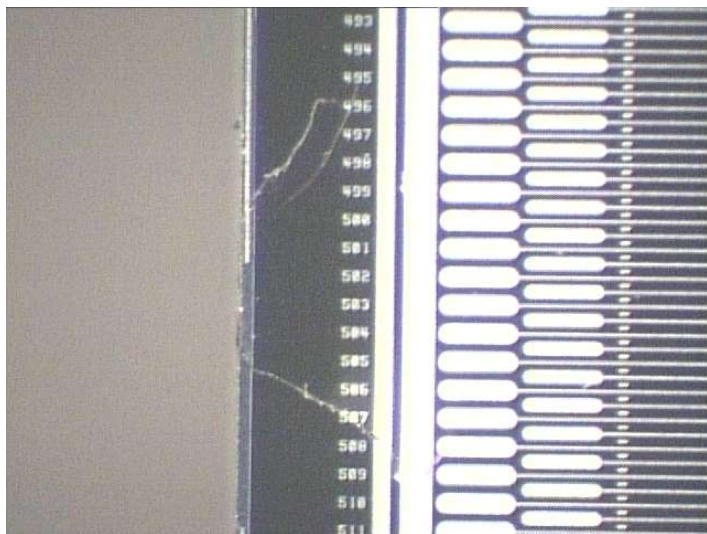
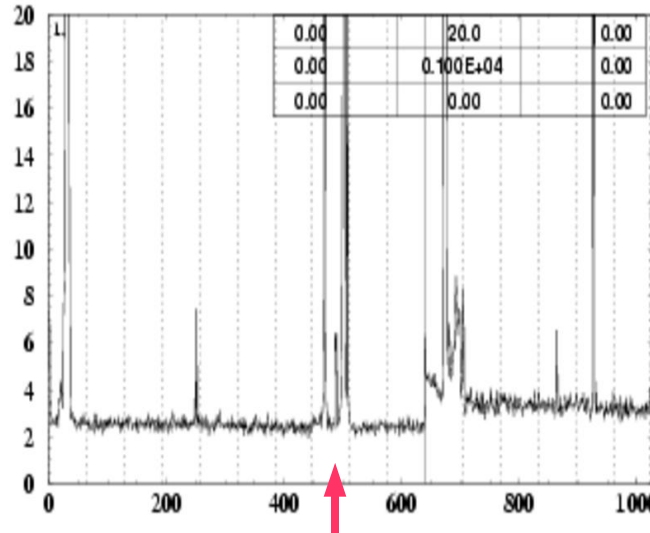
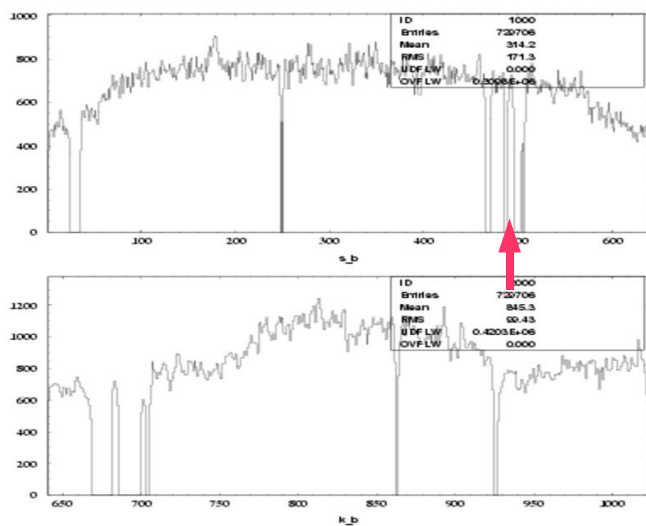
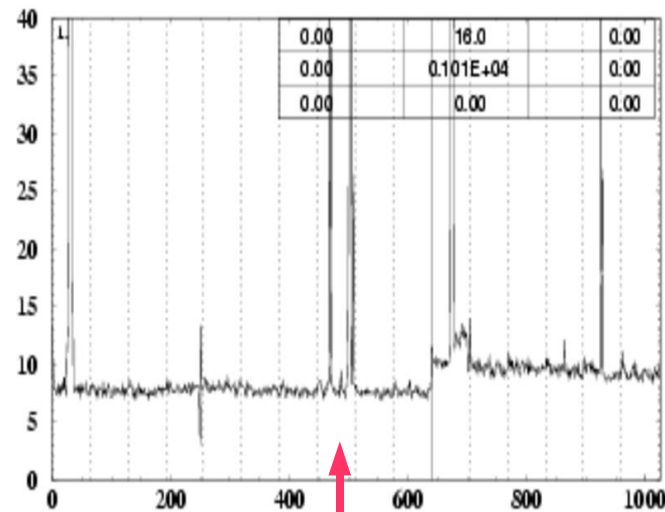
# L15A0094: wafer 15 chipped

***L15AO094 (sensor 15 damaged and more..)***

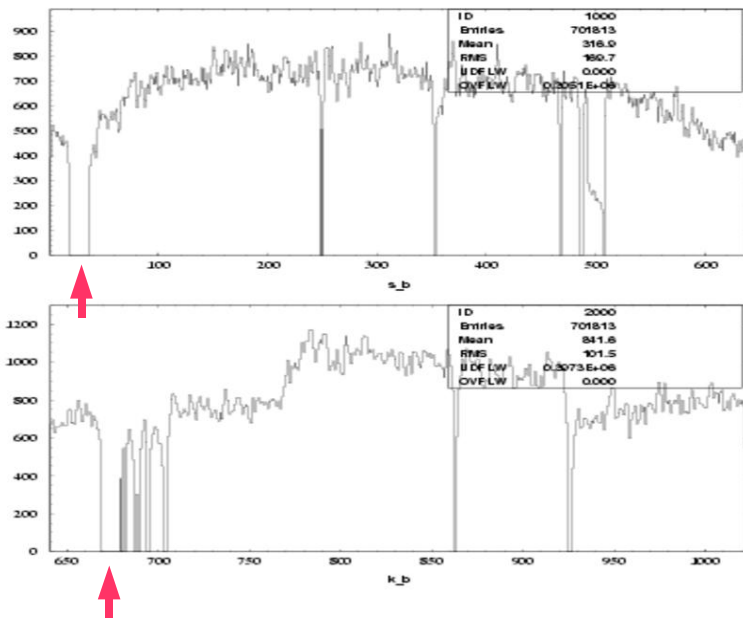
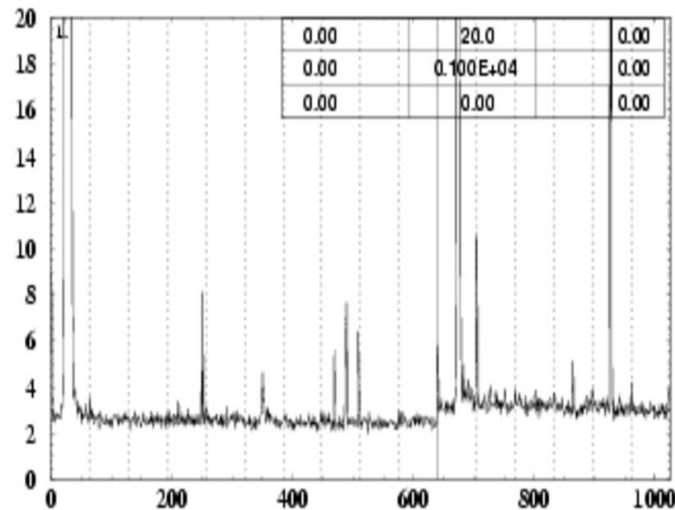
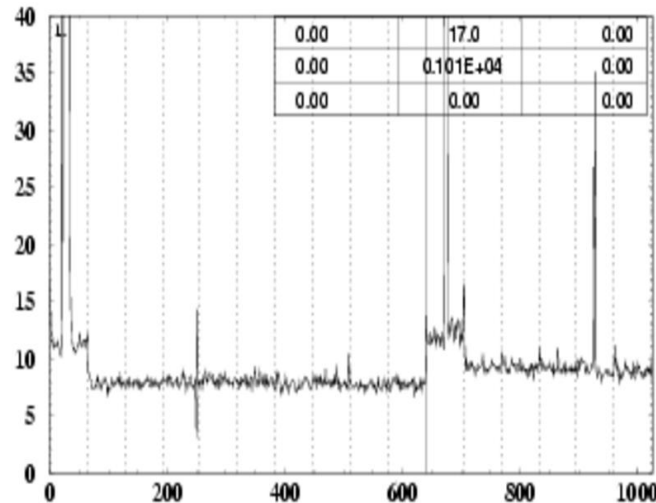
# L15A0094:

*Recovered CHs 495->509 from wafers 14 to 1*  
*Still "hole" on CHs 19->37 and CHs 670->679*  
*Total bad chs: 26 on S-side + 15 on K-side:*  
***keep as it is or reject?***

*bonds 495->509 between wafer 15 and 14 have been disconnected*
