# **Tracker Integration Status at UNIGE**

AMS-02 Tracker - Plane 5

May 10, 2005

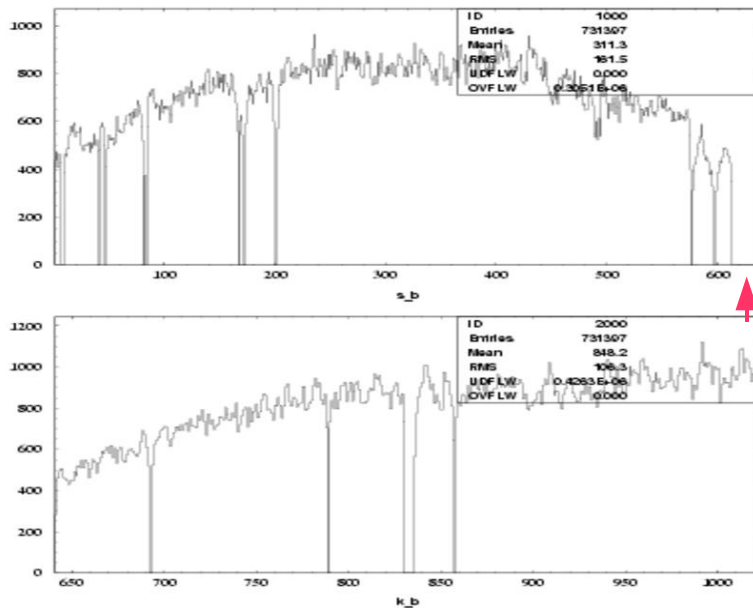
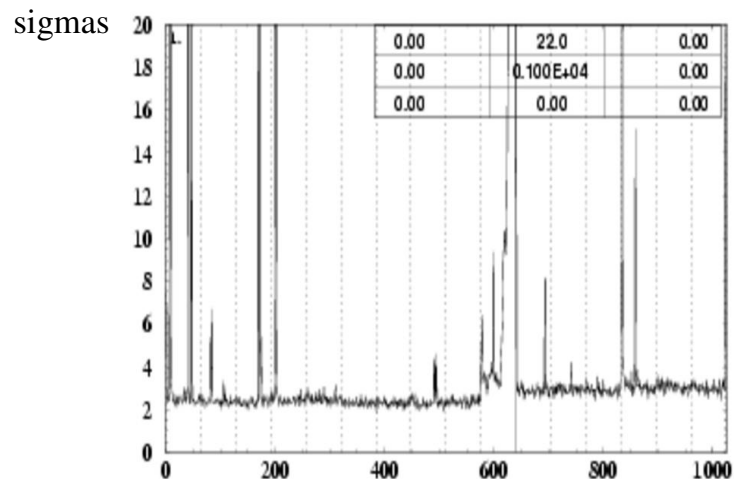
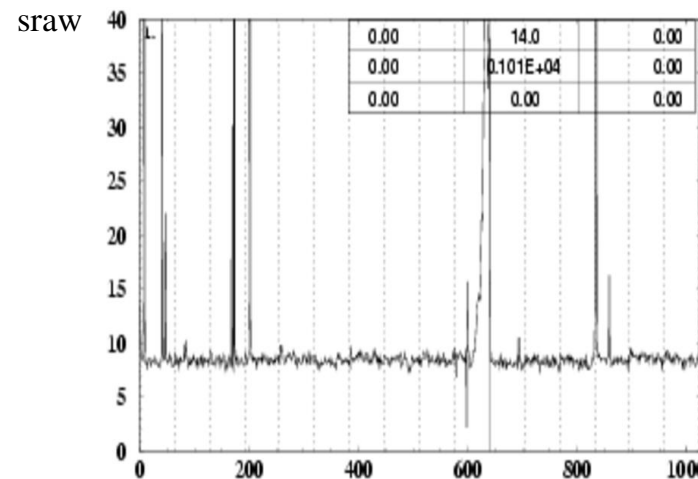
# L12AI067: noisy peak on VA10

Source test

**Being used in the DSP code test**  
 (together with 3 rejected ladders)  
**Needed from Perugia another rejected ladder**  
**to replace L12AI067 in the test setup**

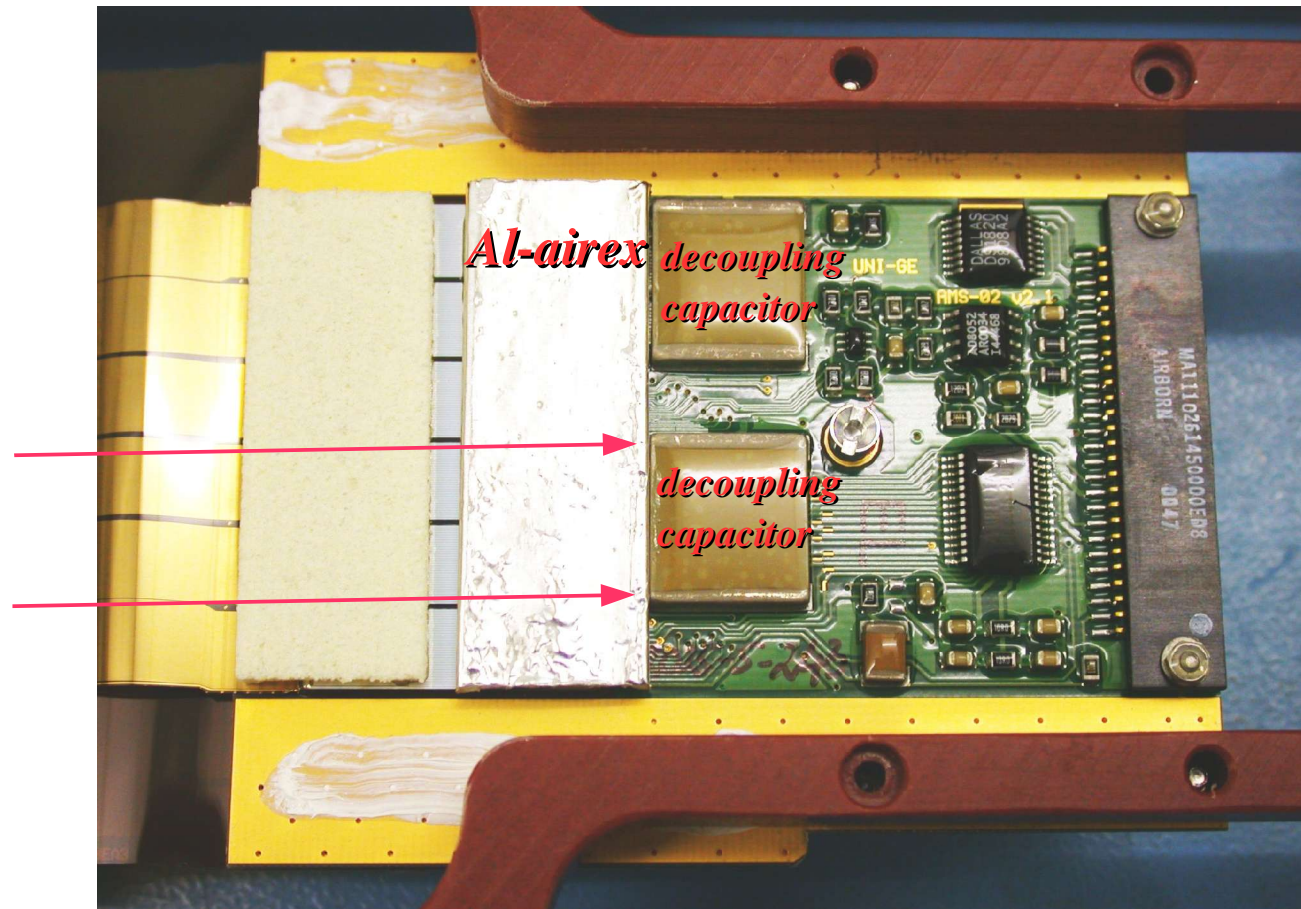
## Solving the L15A0095 mystery:

**Problem:** *Very high leakage current after phase-2*

**Cause:** *Short between S and K local grounds via light-tightness Al-airex cover + hybrids box*

*Al-airex cover  
in contact with  
one of the  
decoupling  
capacitor*

**Solution:** *Insulate Al-airex cover (to be done on all outer ladders)*

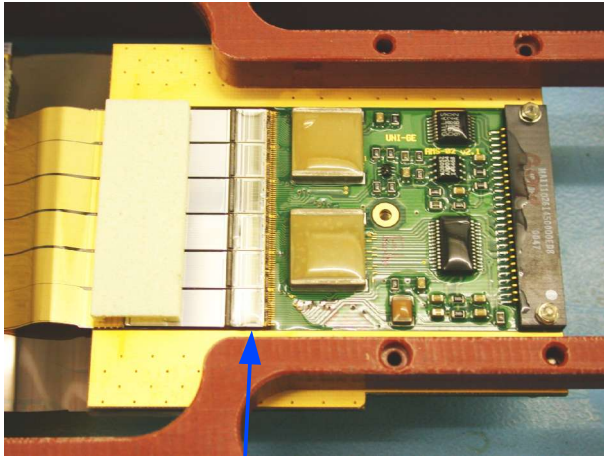
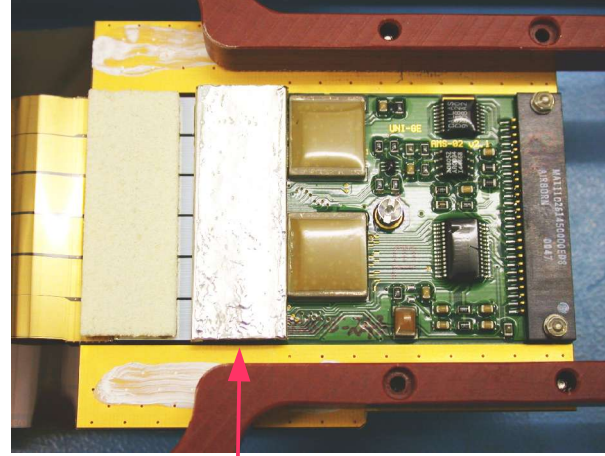
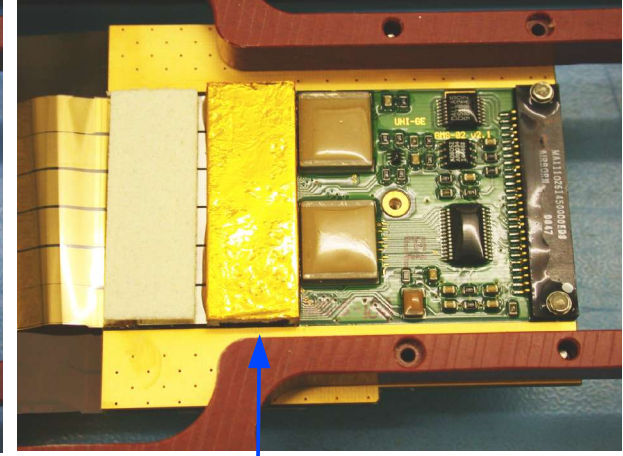
# *Light-tight airex: introduced on outer ladders to protect hybrids VAs from light*

*Light-tight airex 1<sup>st</sup> version :  
Al+ airex cover*

*Light-tight airex last version :  
Al+ airex+insulating scotch*

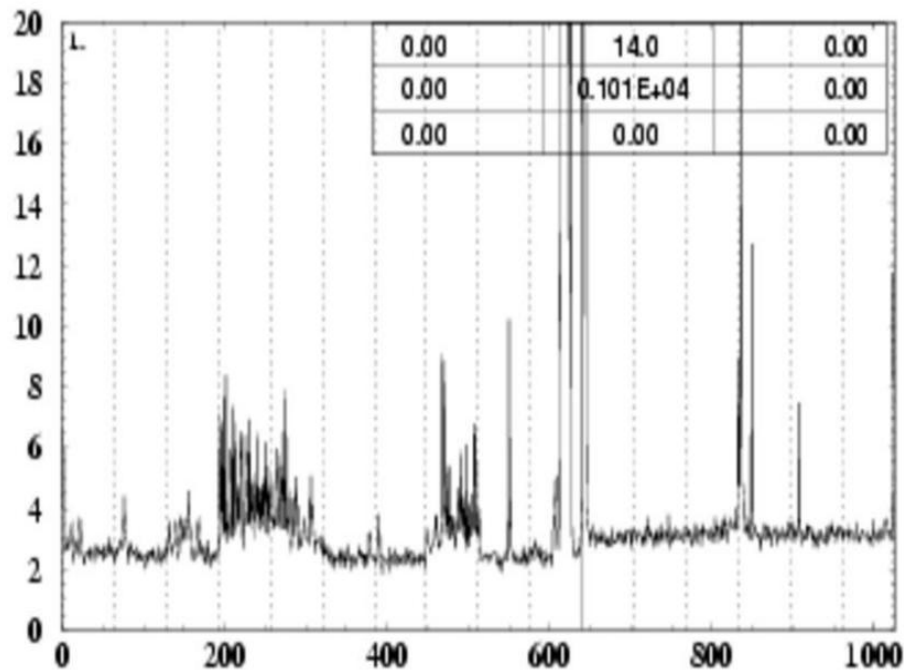
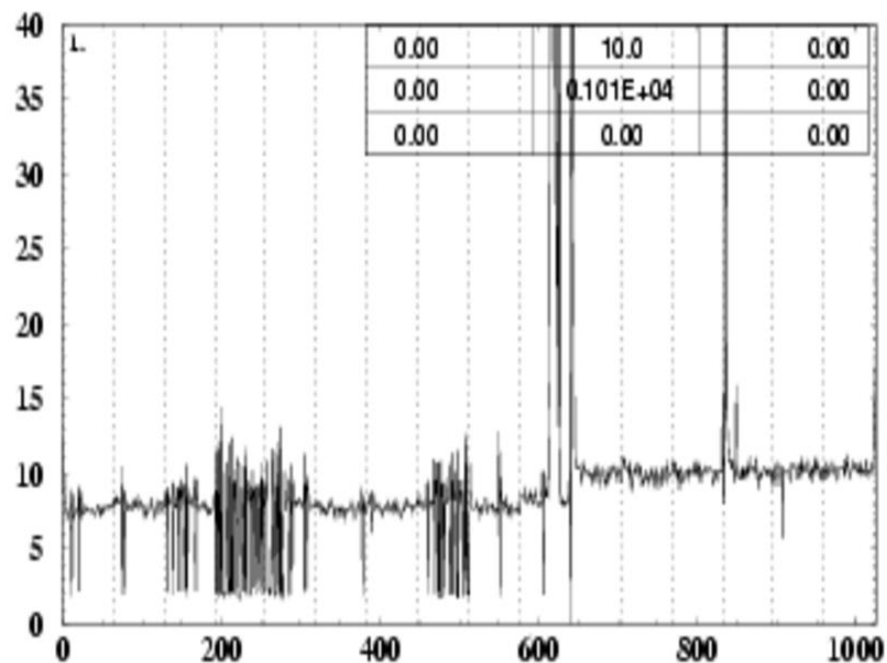
# ***L14AI032: capacitors 1, 2, 3, 4, 5 and 8 damaged***

***Guard-ring voltages: S-side= -4.5 V , K-side= +5.0V; Bias Voltage= 70.5 V  
 (standard values used :S-side= -2.0 V , K-side= +5.0V; Bias Voltage= 73 V)***

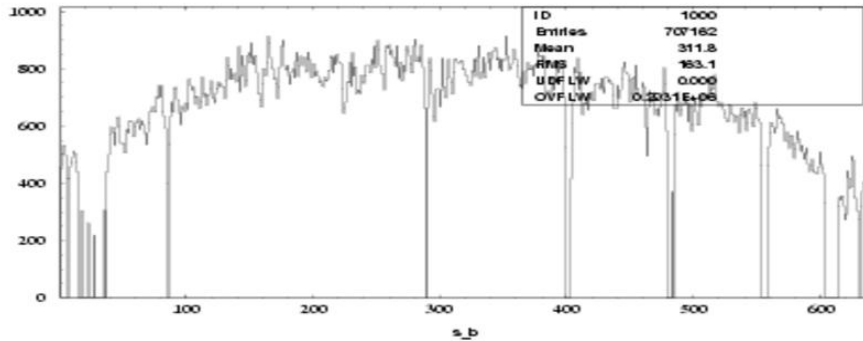
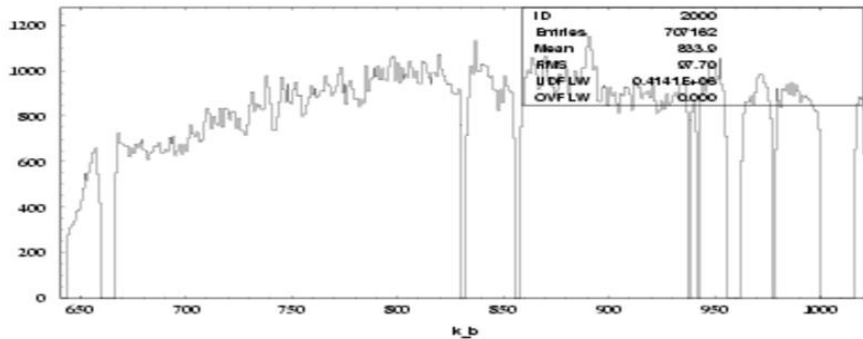
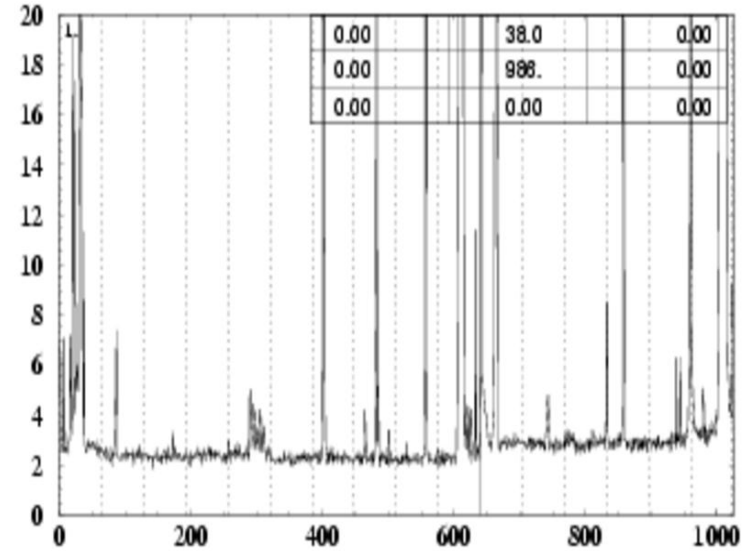
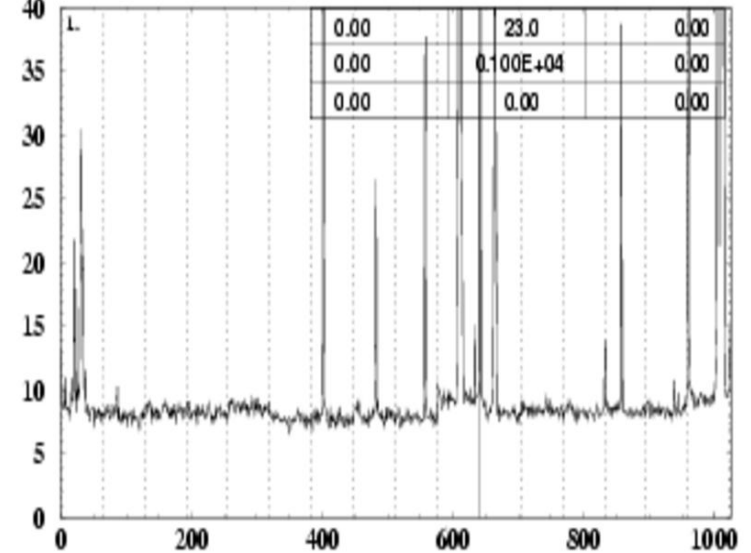
# L12AI016:

- **87 bad channels**  
(45 on S-side + 42 on K-side)
- **S and K hybrids already replaced once**

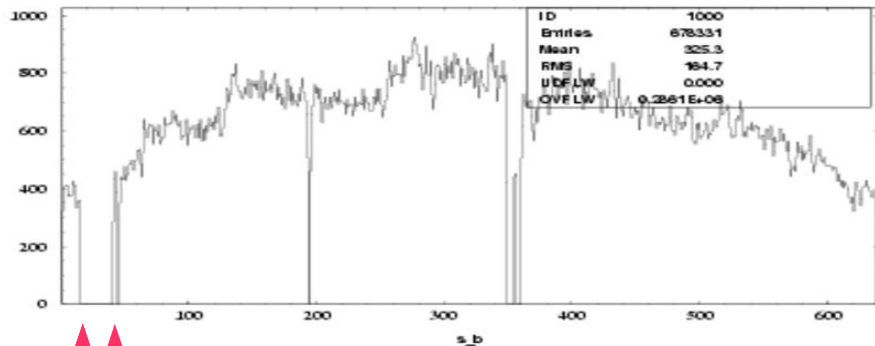
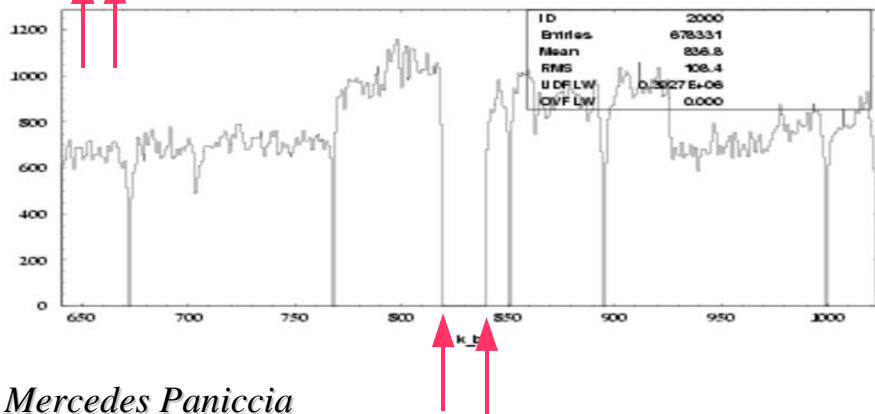
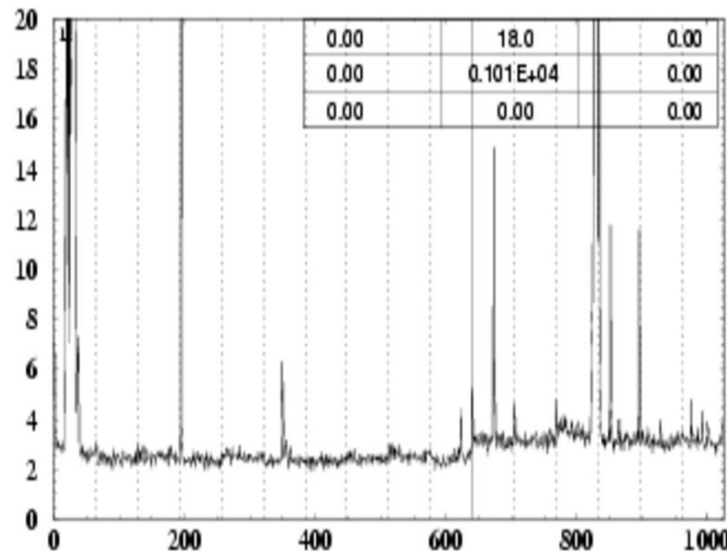
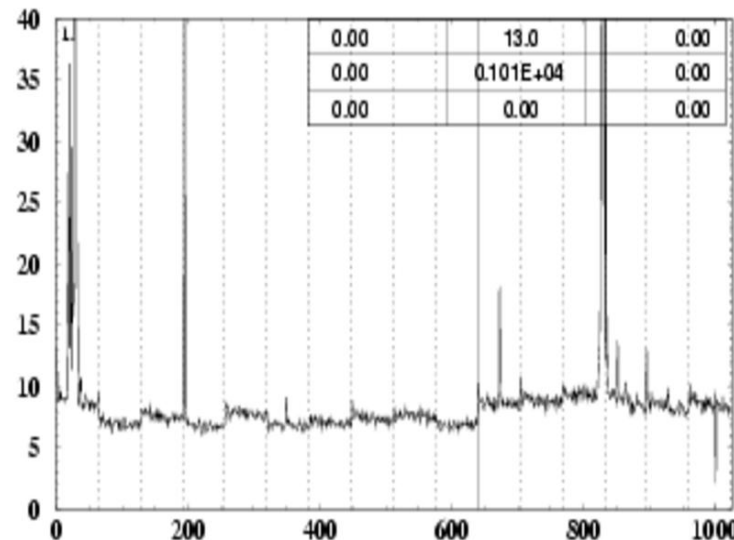
# L15A0161:

- **95 bad channels (60 on S-side + 35 on K-side)**
- **S-side hole 26 channels wide**
- **K-side hole 20 channels wide**
- **Problem likely due to silicon**

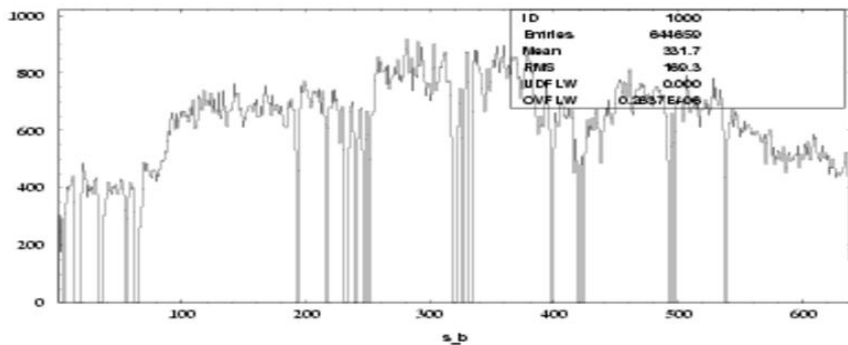
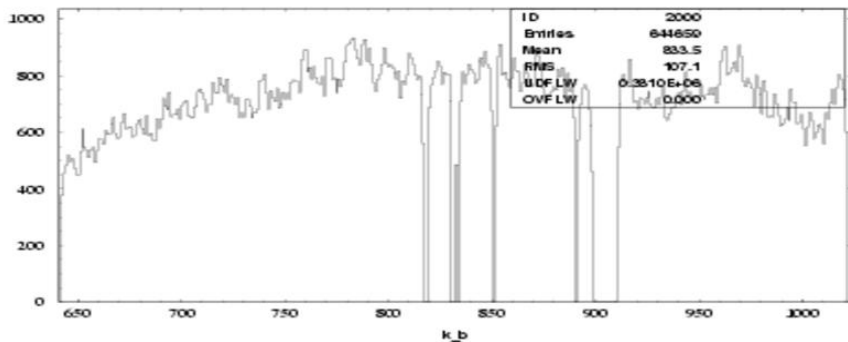
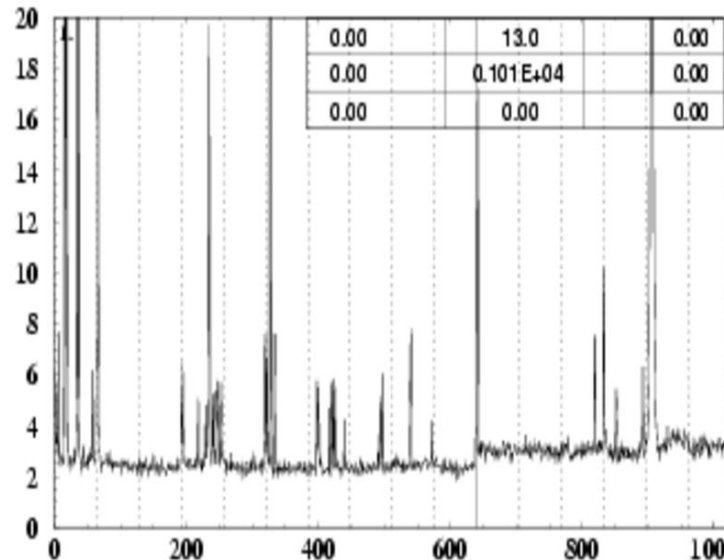
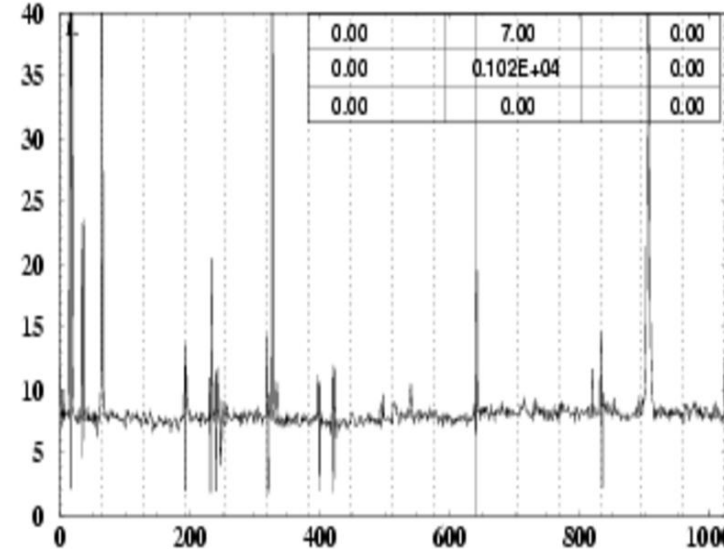
# L12AH028:

- **from 34 to 63 bad channels after shielding**
- **S-hybrid already replaced once**
- **test with variable S guard-ring voltage has not shown supplementary dead channels**

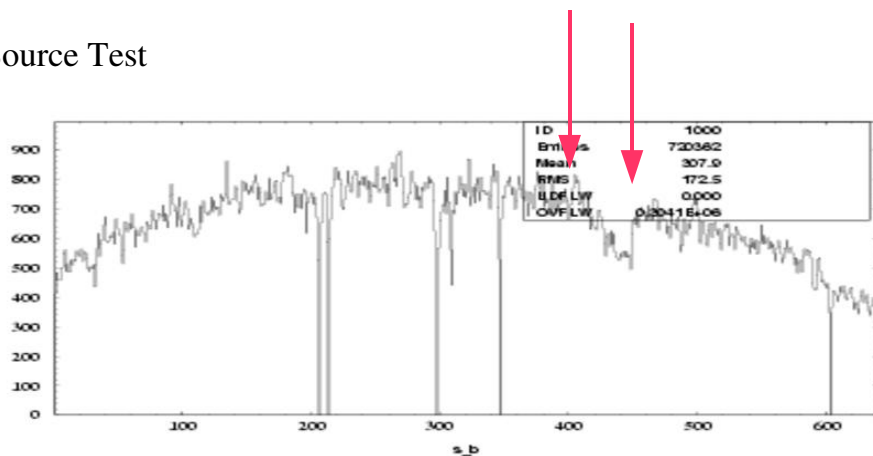
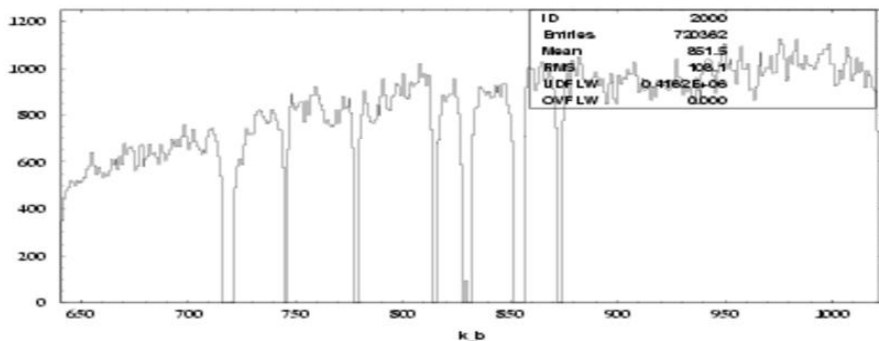
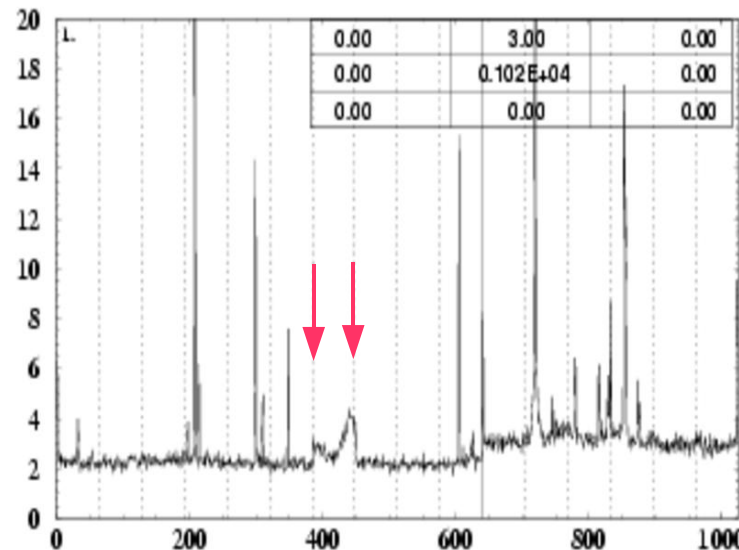
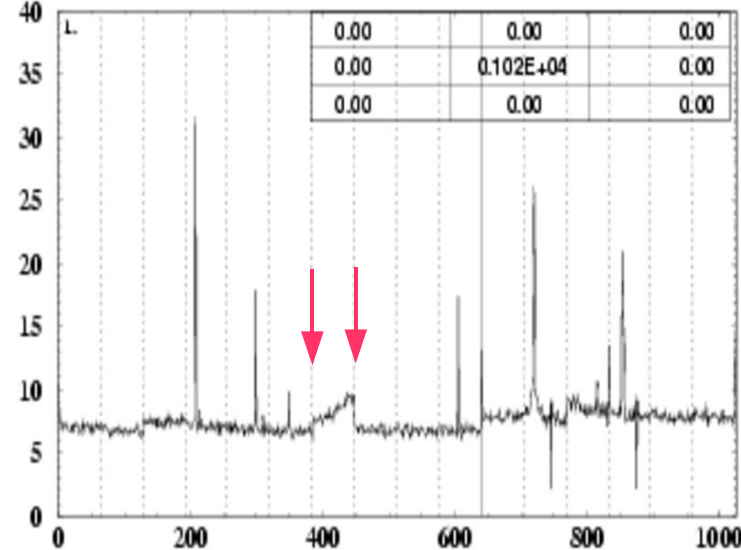
# L12AH058:

- *S hybrid VA 7 strange feature*
- *S hybrid already replaced once accept or try to repair?*

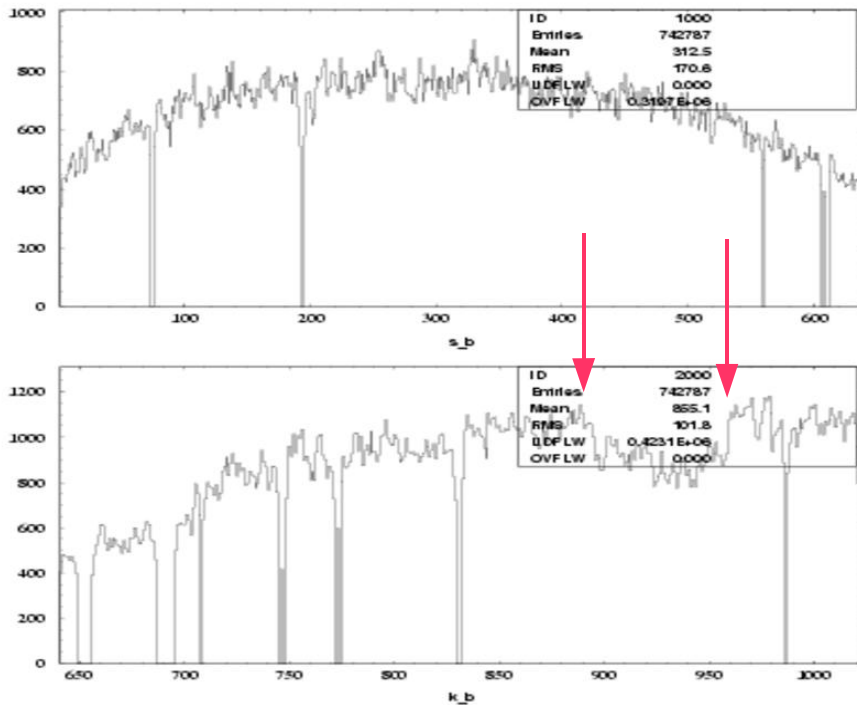
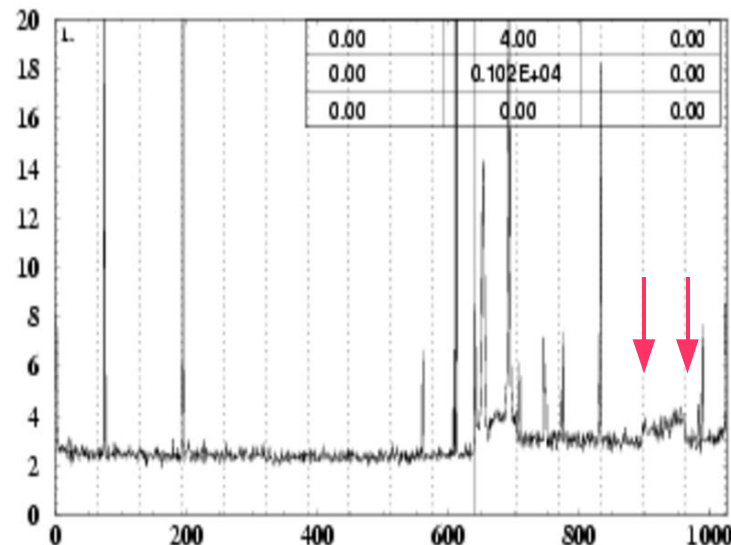
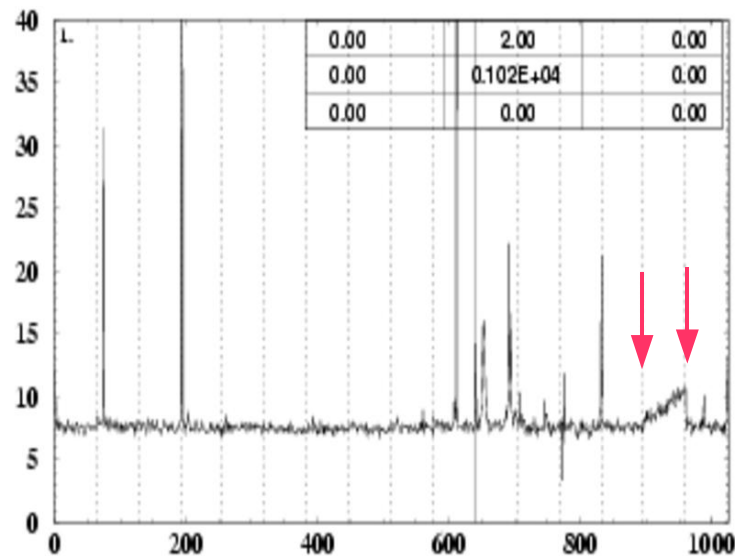
# L12AJ033:

- **K hybrid VA 15 strange feature**
- **K hybrid already replaced once accept or try to repair?**

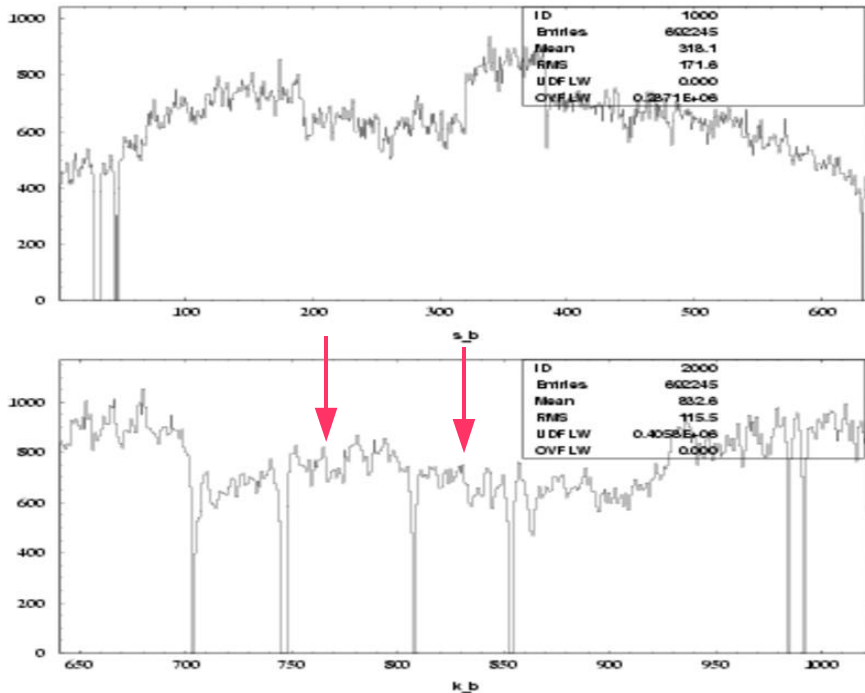
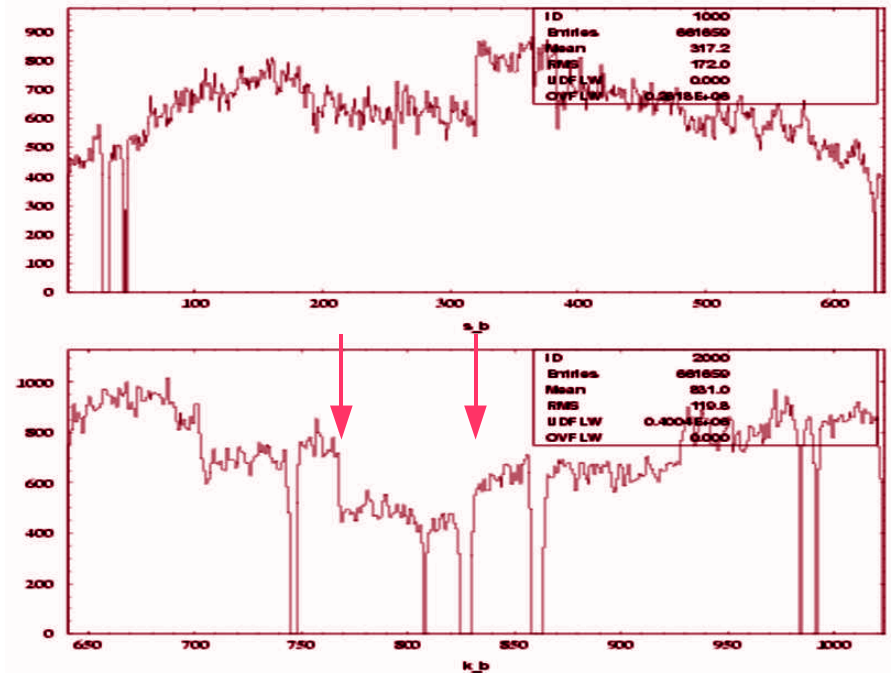
**L14A0125: VA 13 lower gain after phase-2**  
*also tested with triggered source in Perugia*  
*accept or try to repair?*

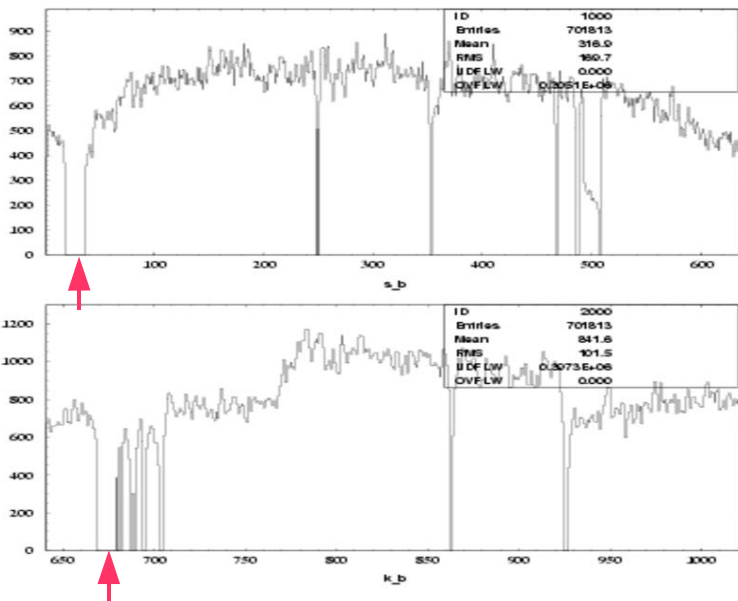
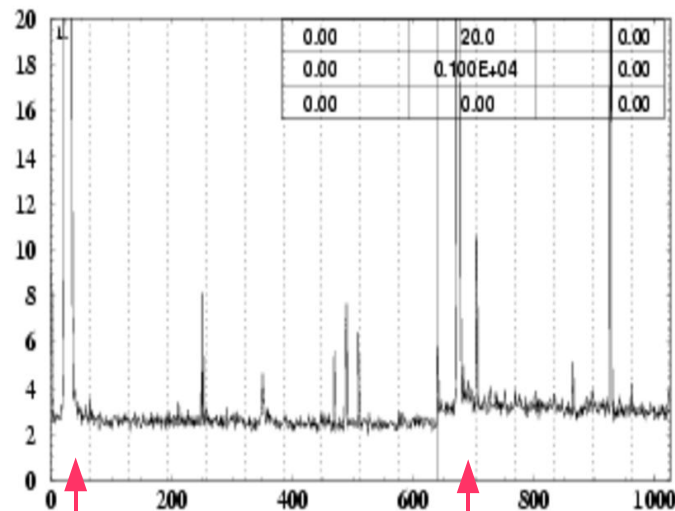
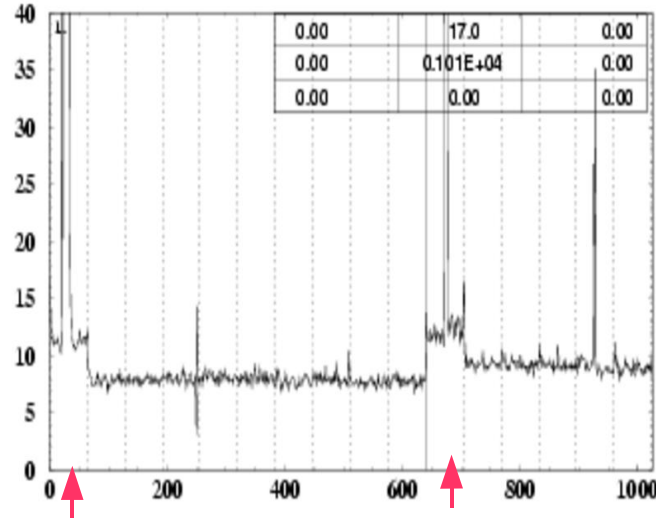
# L15A0094:

after disconnecting

bonds 495->509 between wafer 15 and 14

Recovered CHs 495->509 from wafers 14 to 1  
Still "hole" on CHs 19->37 and CHs 670->679

Total bad chs: 26 on S-side + 15 on K-side

**Proposal at previous Tracker meeting:  
test with wafer 15 completely disconnected  
and eventually replace wafer 15**

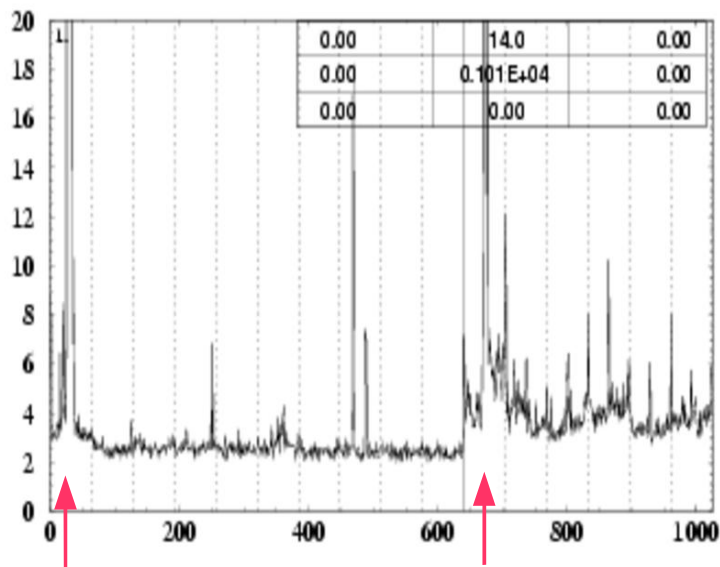
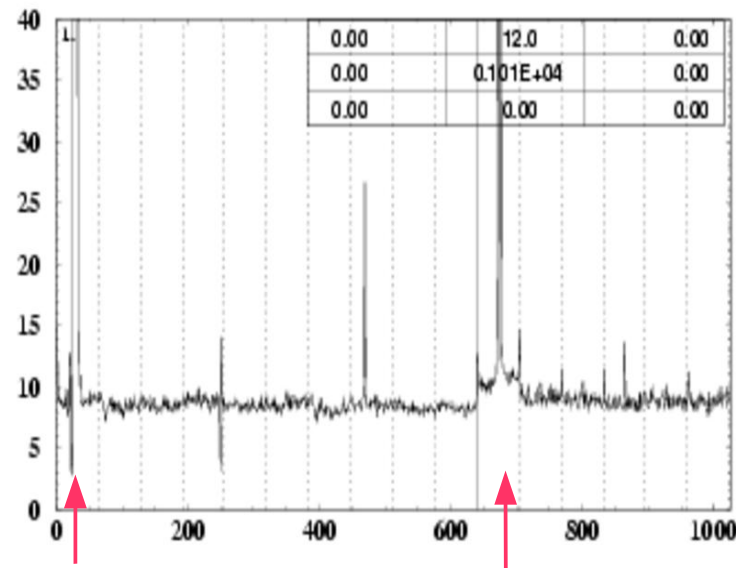
***L15A0094 after completely disconnecting wafer 15:***

*The problem on VAs 1 and 11 is caused by another sensor (or more), thus just changing wafer 15 will not save the ladder!*

***Rejected after discussion with G.Ambrosi, Ph. Azzarello and M. Ionica spare ladder to replace this one already foreseen.***
