Production and Integration Status

Ladders installed on planes...

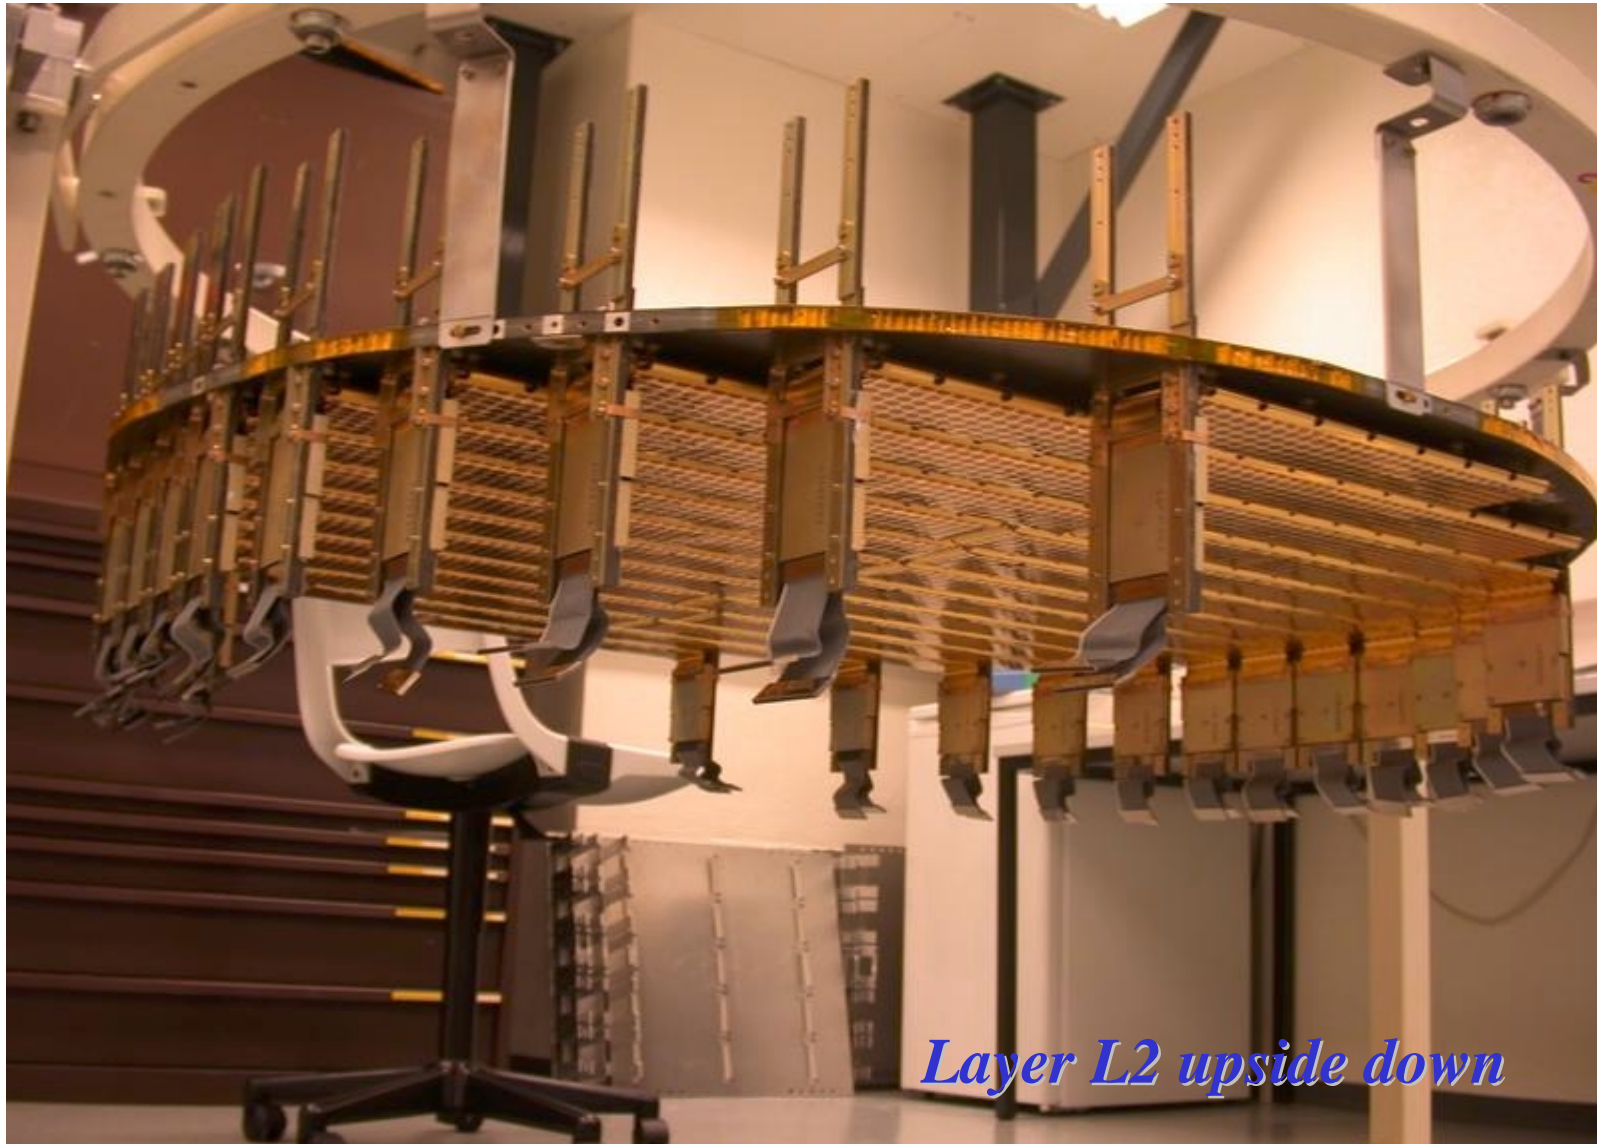
Layer L2 upside down

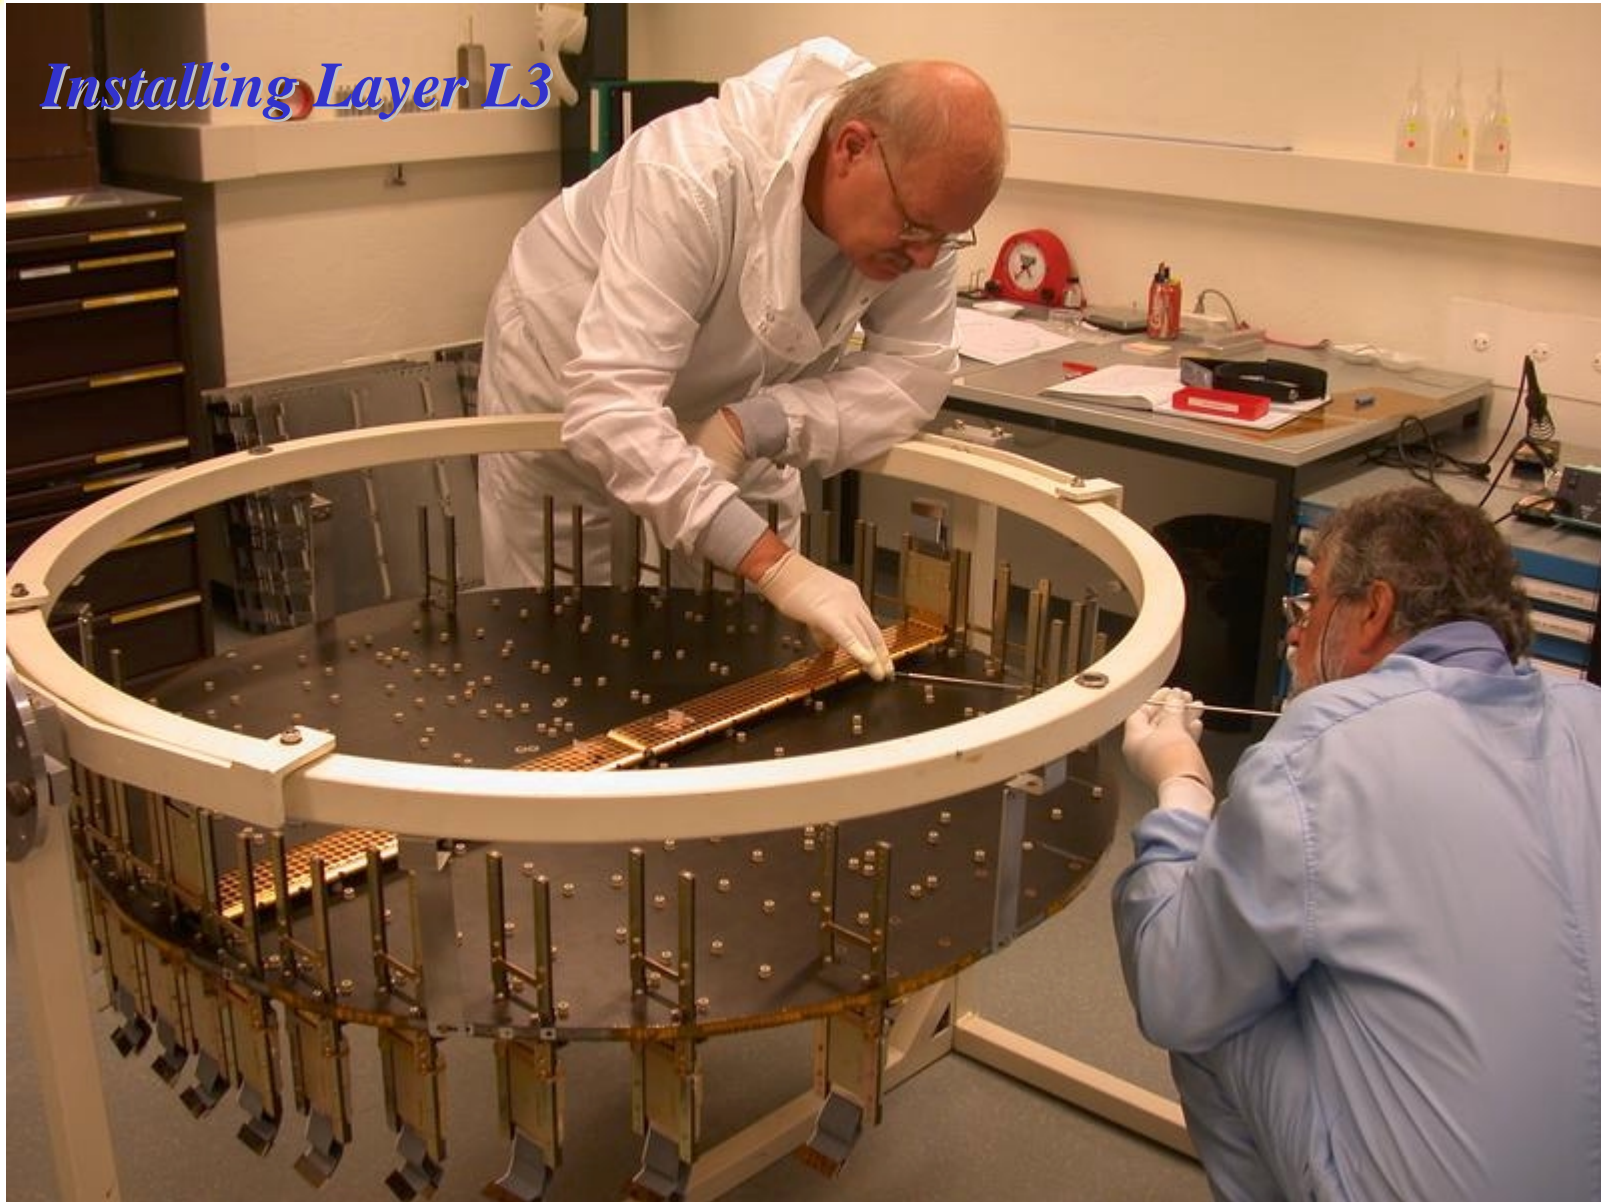
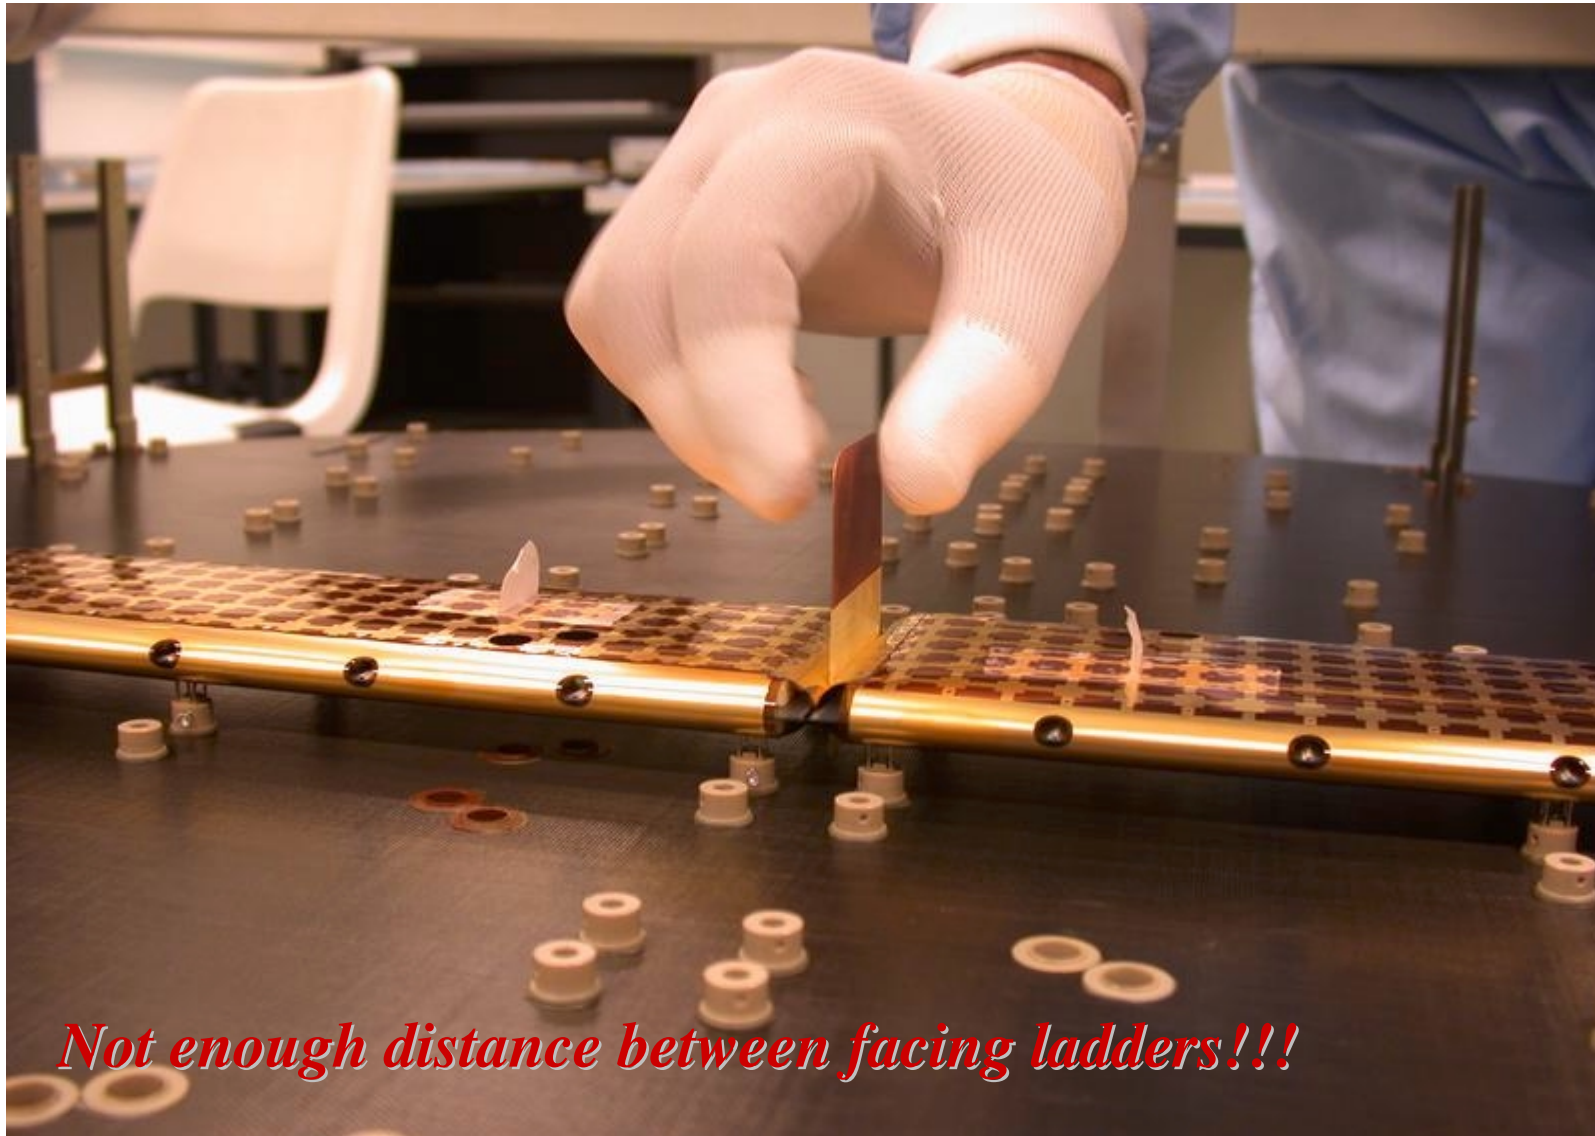
Installing Layer L3

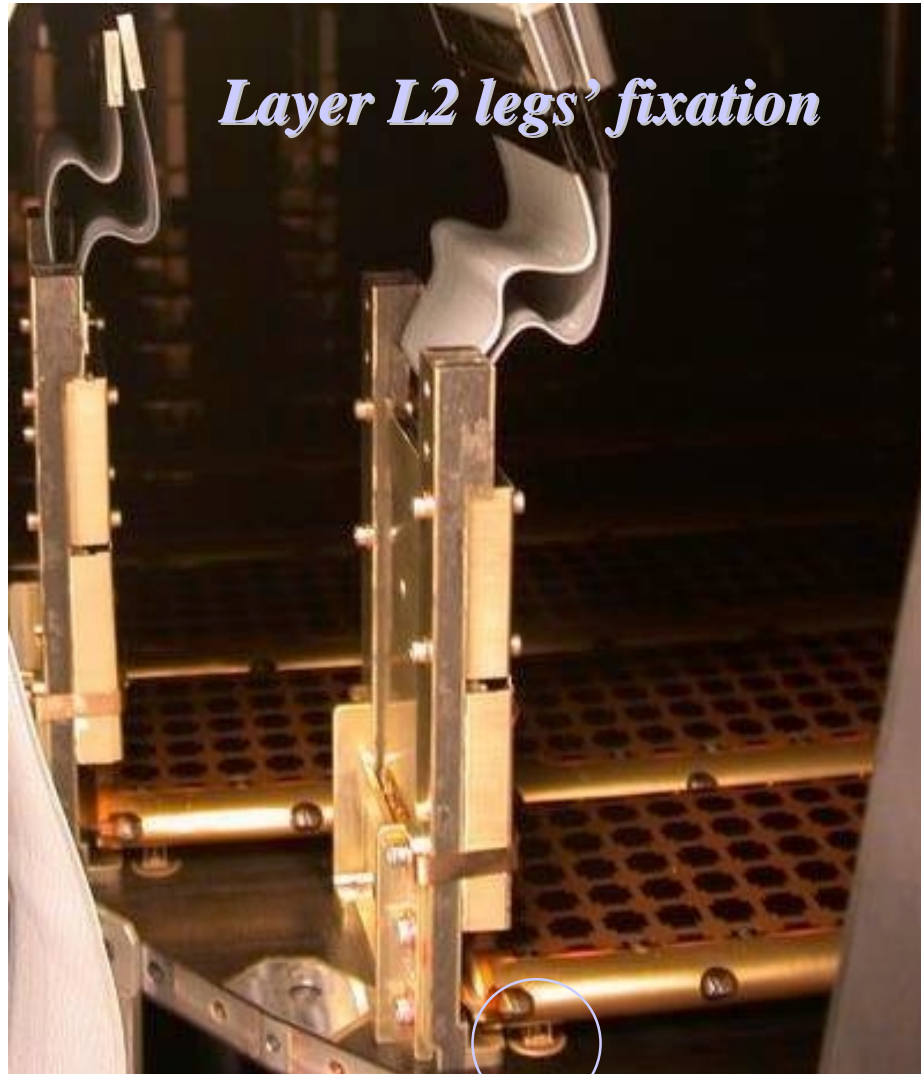
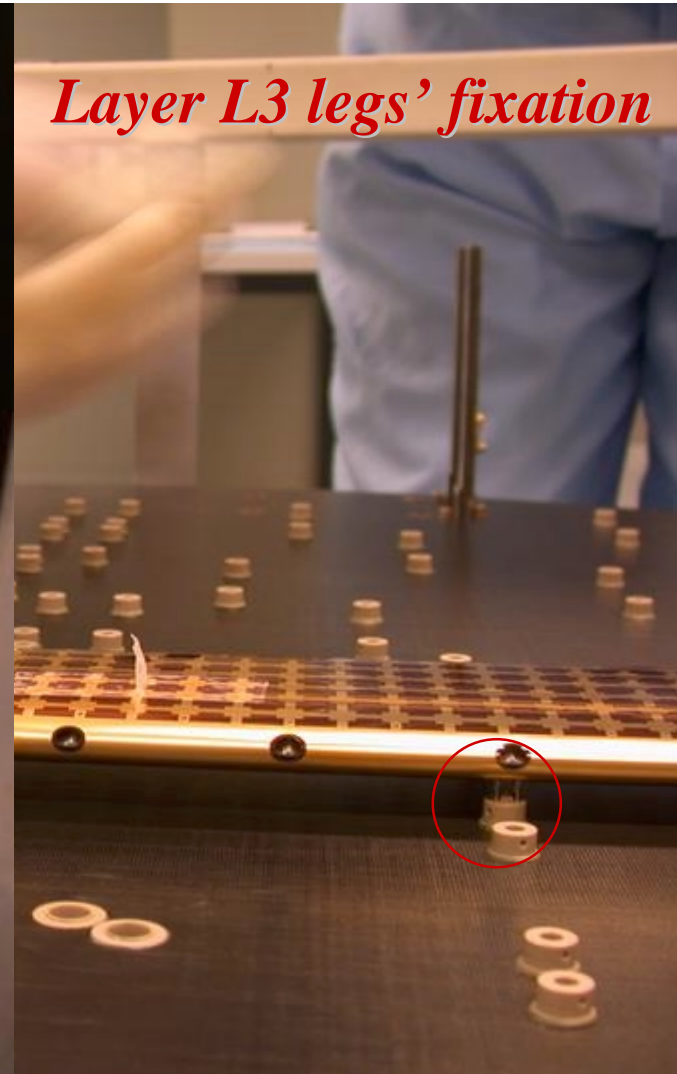
Not enough distance between facing ladders!!!

the distance between ladders should be enough to prevent them from touching each other (and eventually break) during vibrations which will take place at the launch, with the particular legs' fixations used for layers L3, L5 and L6 the space left is less than the minimum needed (300 μm) !

gain flexibility gluing legs on ladders more away from Hybrids box

*First attempt: 70 μm **STILL NOT ENOUGH***

*Second attempt: 140 μm **OK***

From now on this procedure has been adopted for every ladder entering phase-2 manipulations (No effects on upper layers)

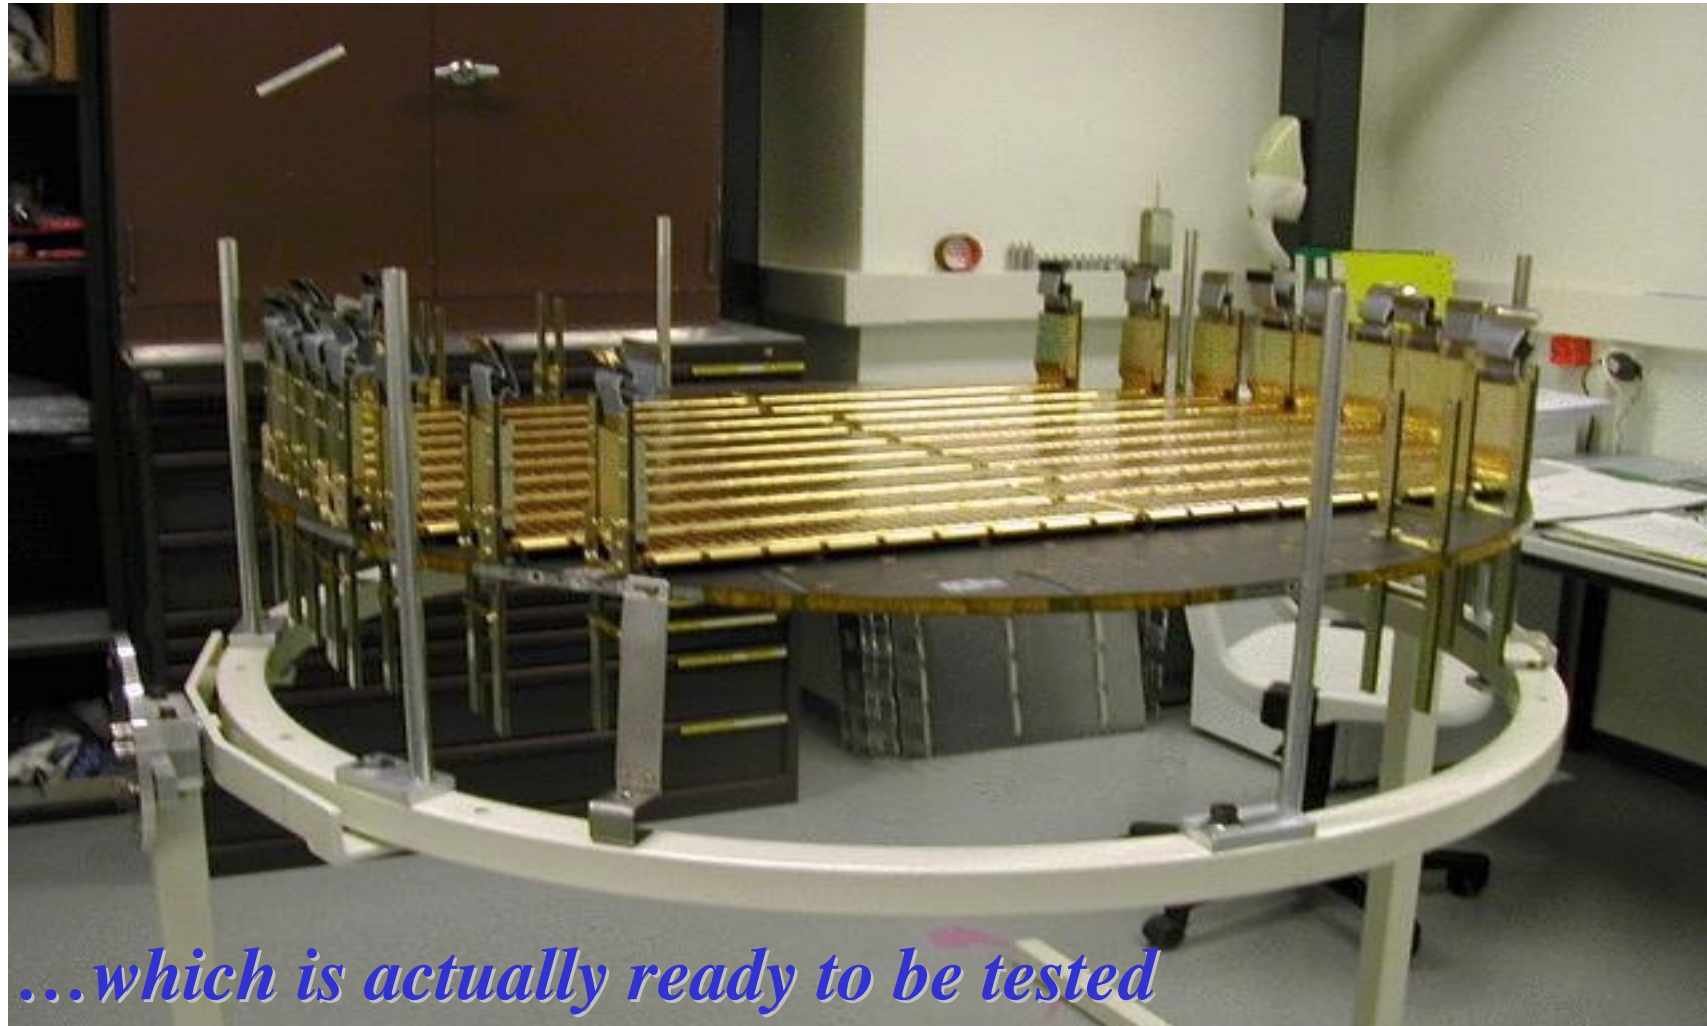
Then layer L4 was next:

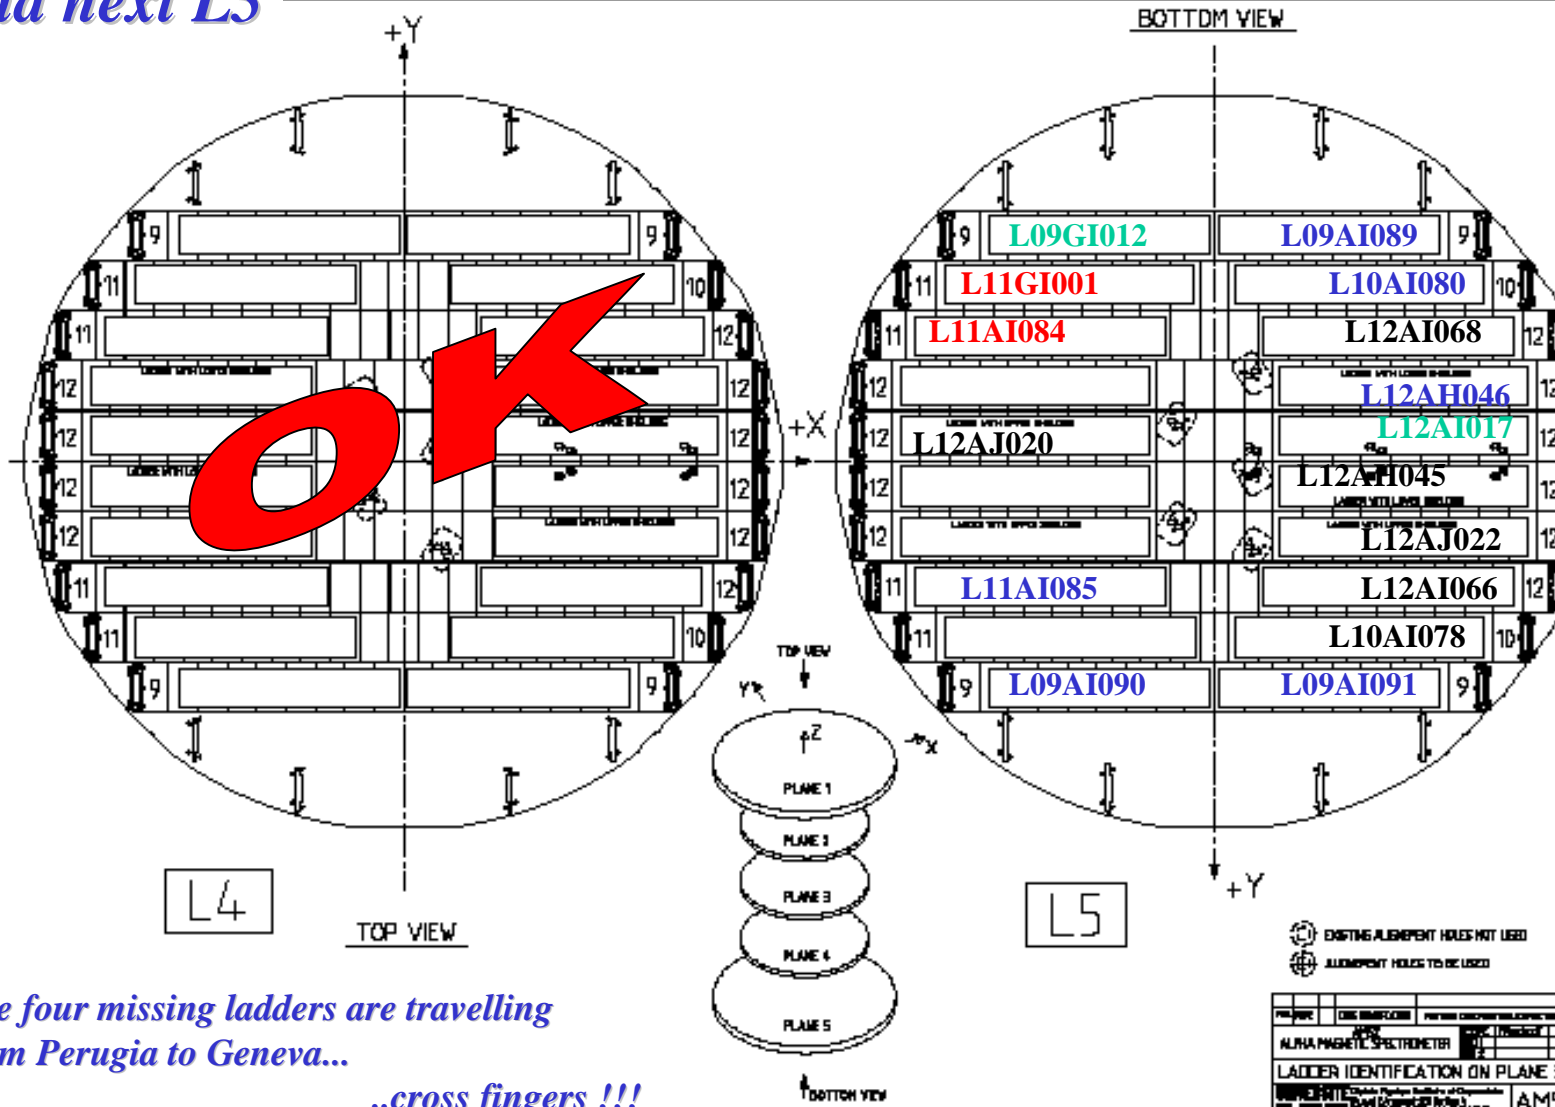
And next L5

*The four missing ladders are travelling from Perugia to Geneva...
 ..cross fingers !!!*
