# **Tracker Integration Status at UNIGE**

AMS-02 Tracker - Plane 5

May 10, 2005

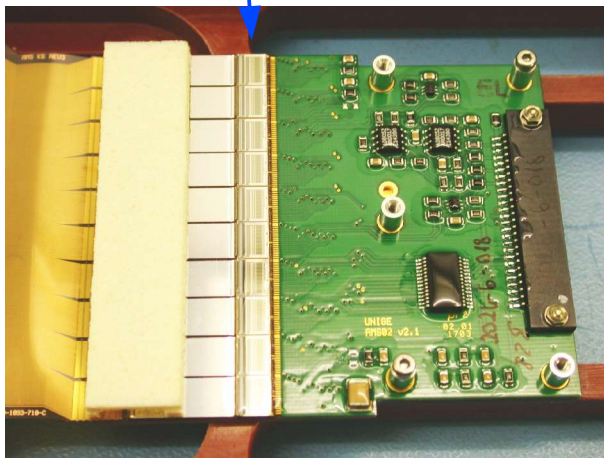
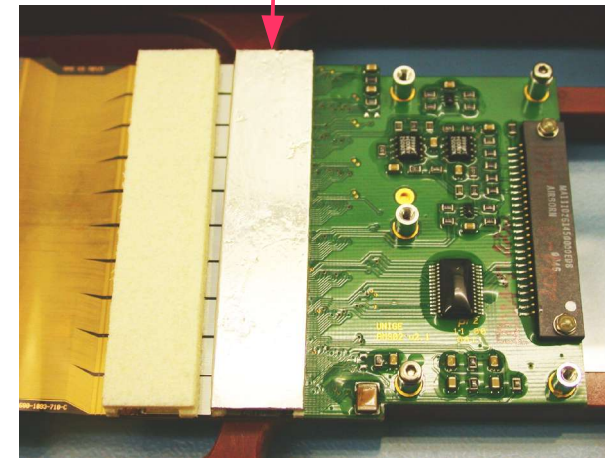
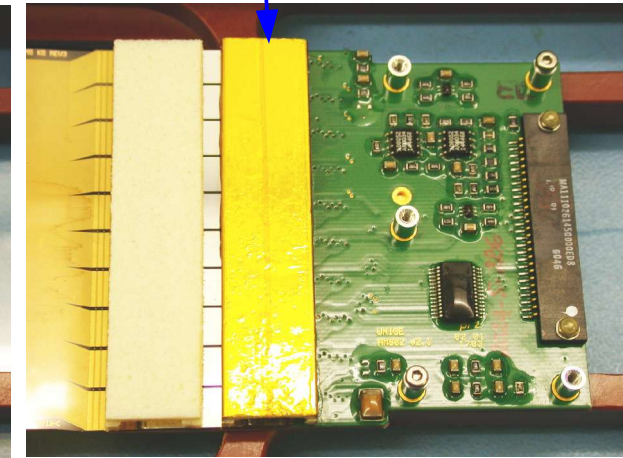
**Problem:** *Very high leakage current after phase-2*

**Cause:** *Short between S and K local grounds via light-tightness Al-airex cover + hybrids box*

*Light-tight airex last version :  
Al+ airex+insulating scotch*

**Solution:** *Insulate Al-airex cover (to be done on all outer ladders)*

## ***Additional work to be done on OUTER ladders :***

- ***Insulate Al-airer cover*** (need to open hybrids box of most of outer ladders )
