# **Integration Status**

# **UNIGE**

# AMS-02 Tracker - Plane 2

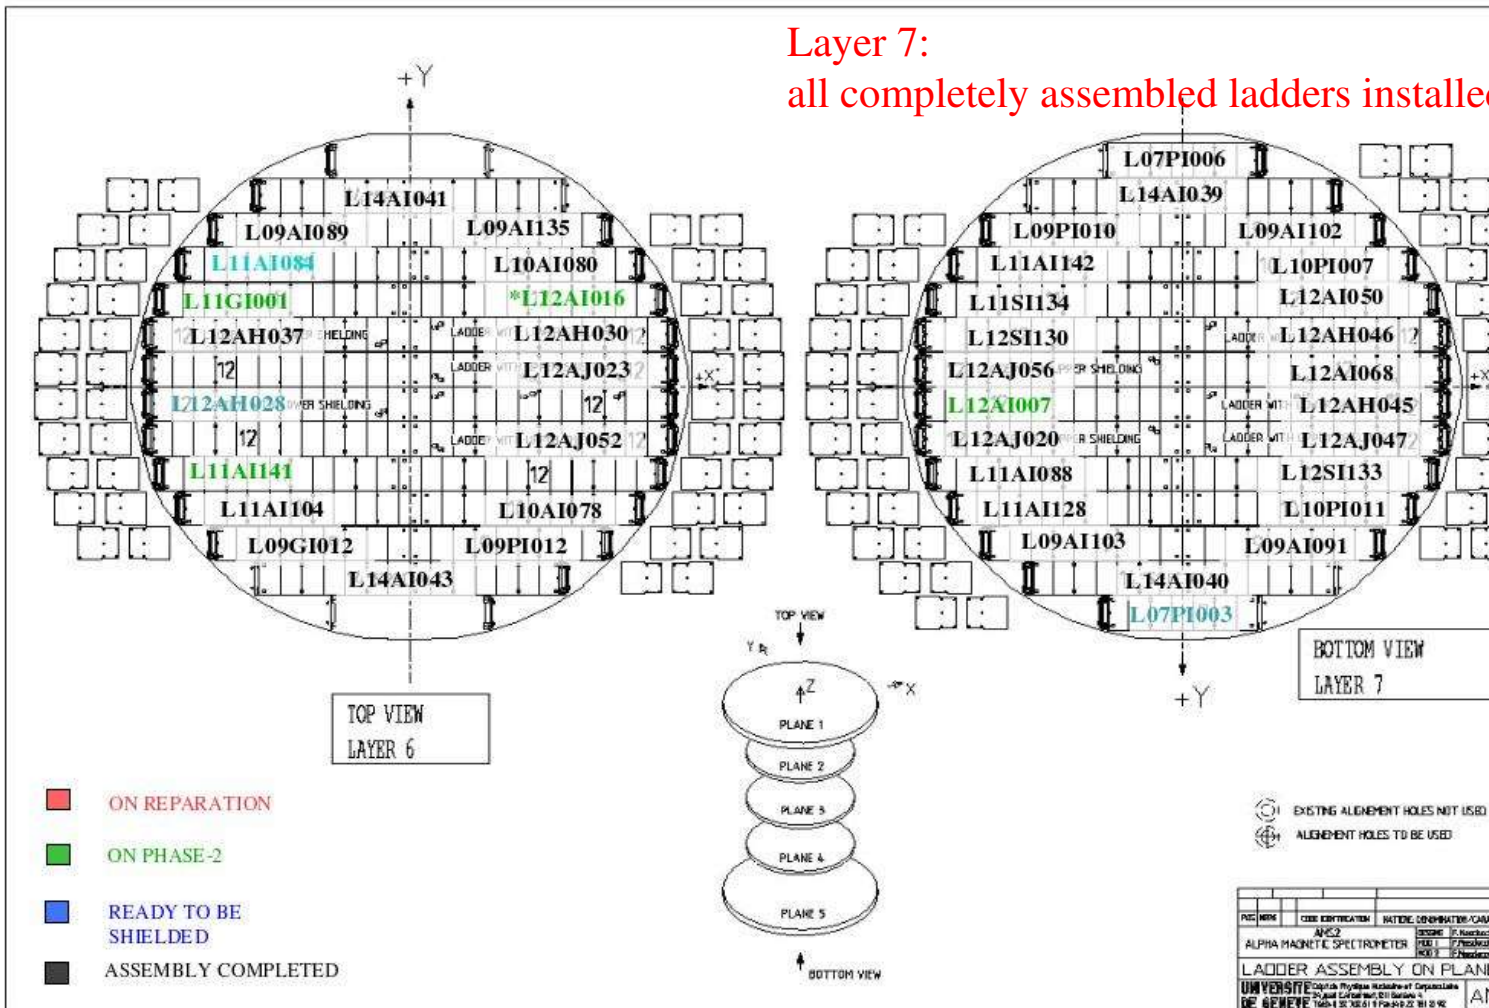
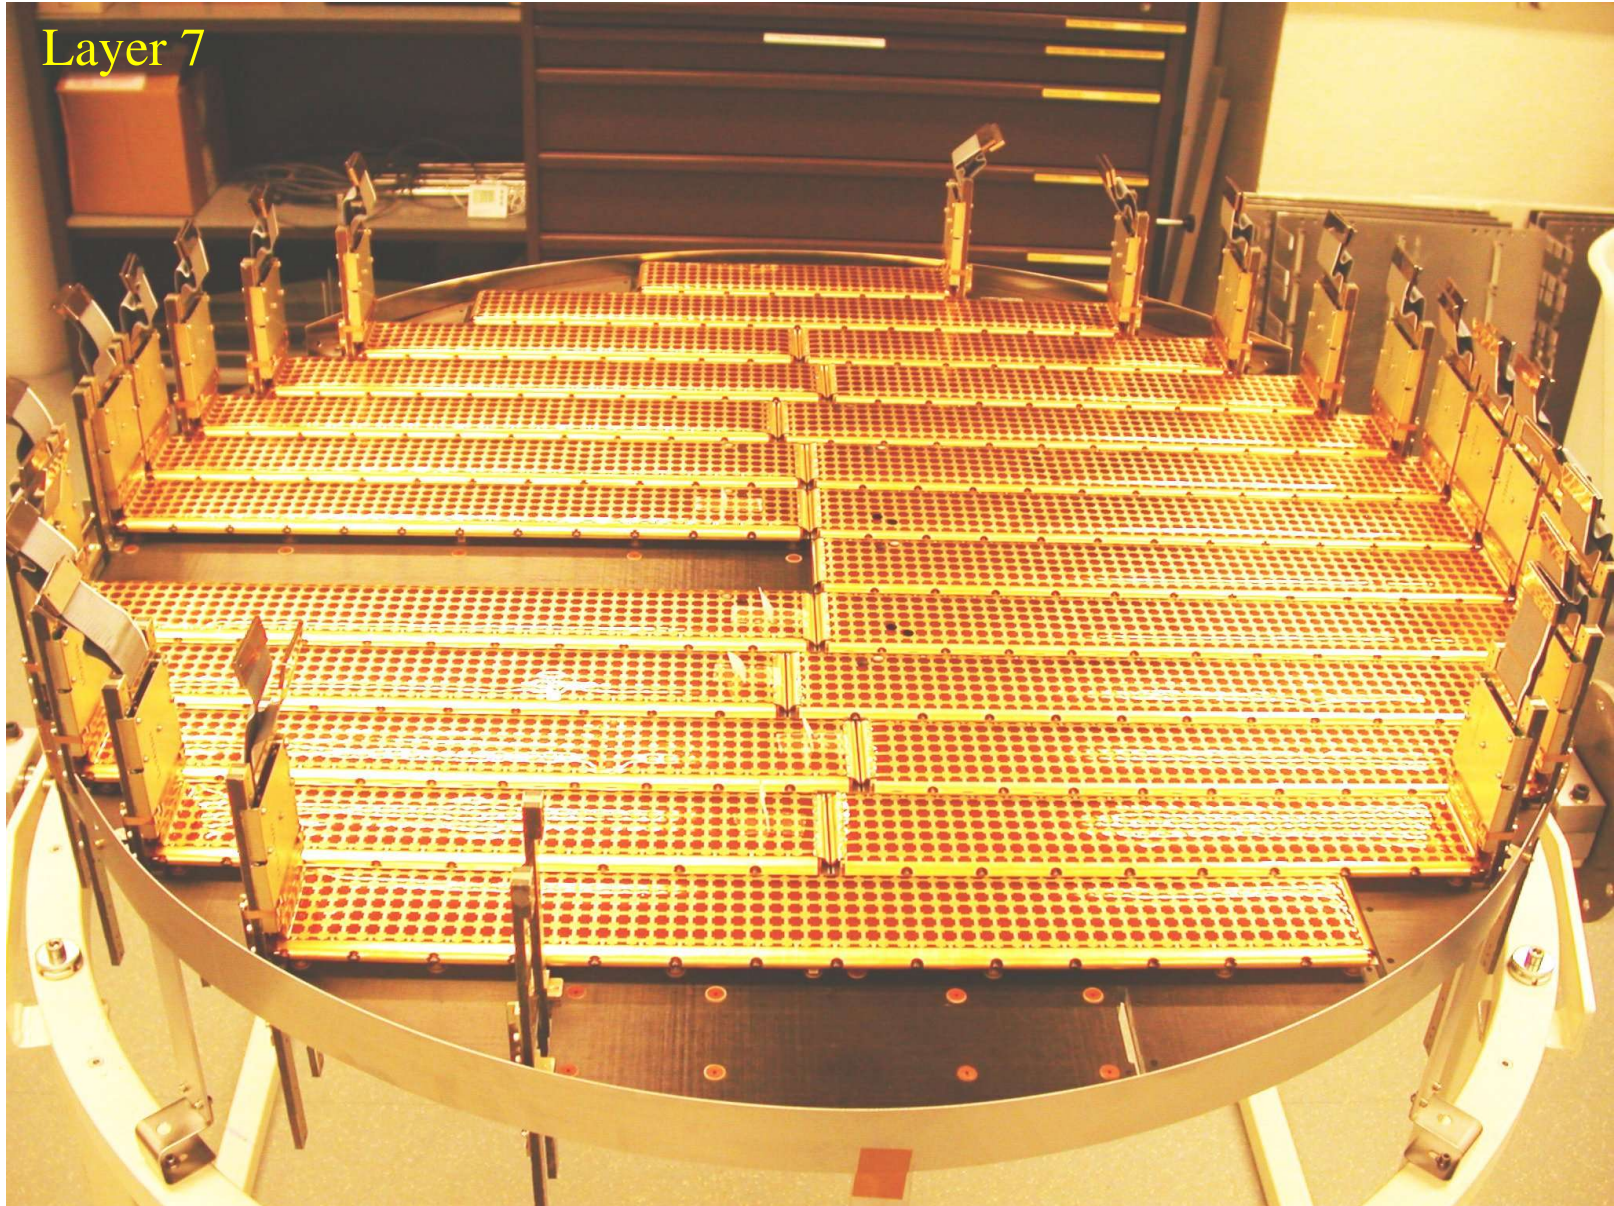
Layer 7

***Problem during L7 installation: S side airex unglued on L09AI091***

***Fixing: add redundant airex gluing points on both sides (S&K) for all ladders***
